Sunset Harbor Condominium

3873 South Banana River Boulevard
Cocoa Beach, Florida 32931

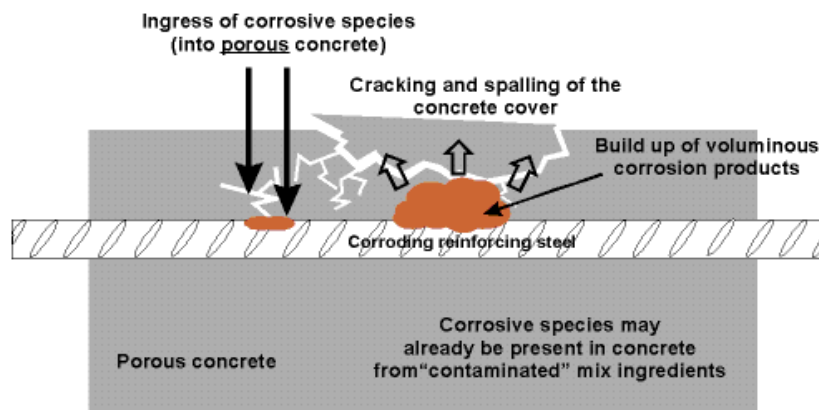
One of the most significant factors in the time and magnitude of reinforcing steel corrosion induced concrete damage is the ease of access for the chlorides to enter the concrete. Properly sealing and waterproofing the building, including all

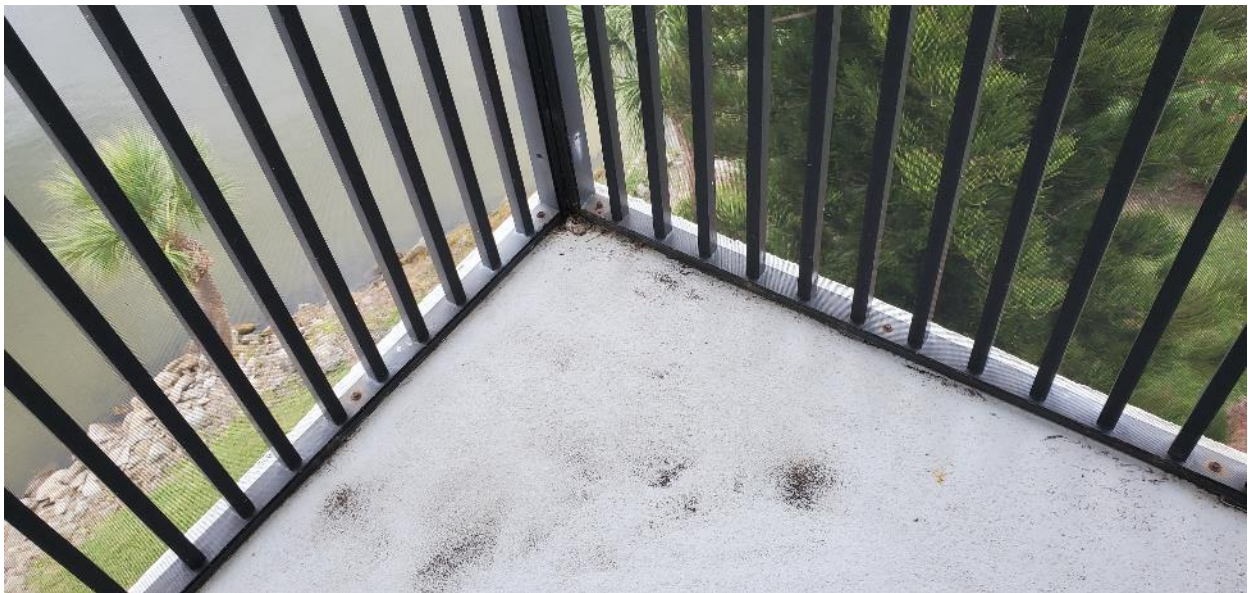
Corroded fasteners on screen enclosure

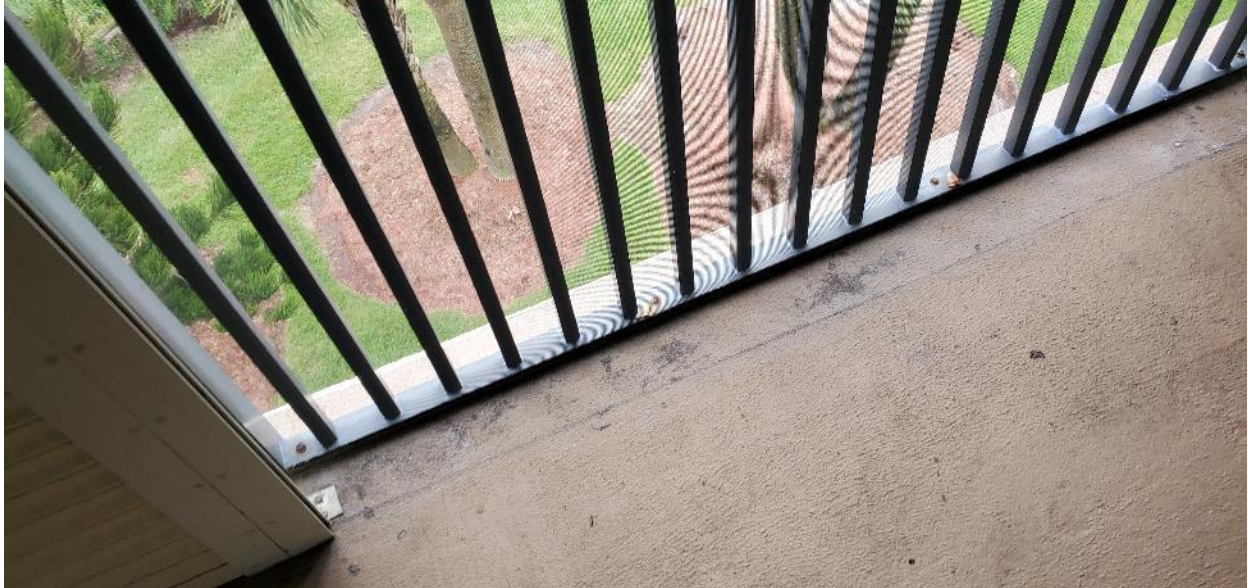
Corroded fasteners on screen enclosure

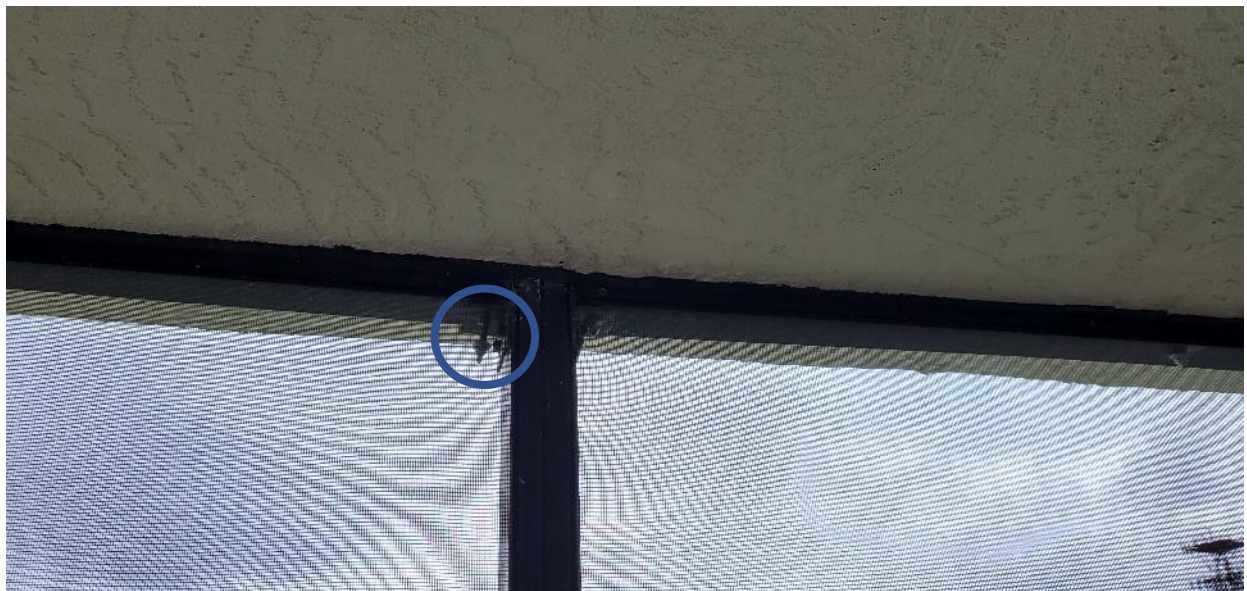
Screen enclosure fastener not embedded into concrete

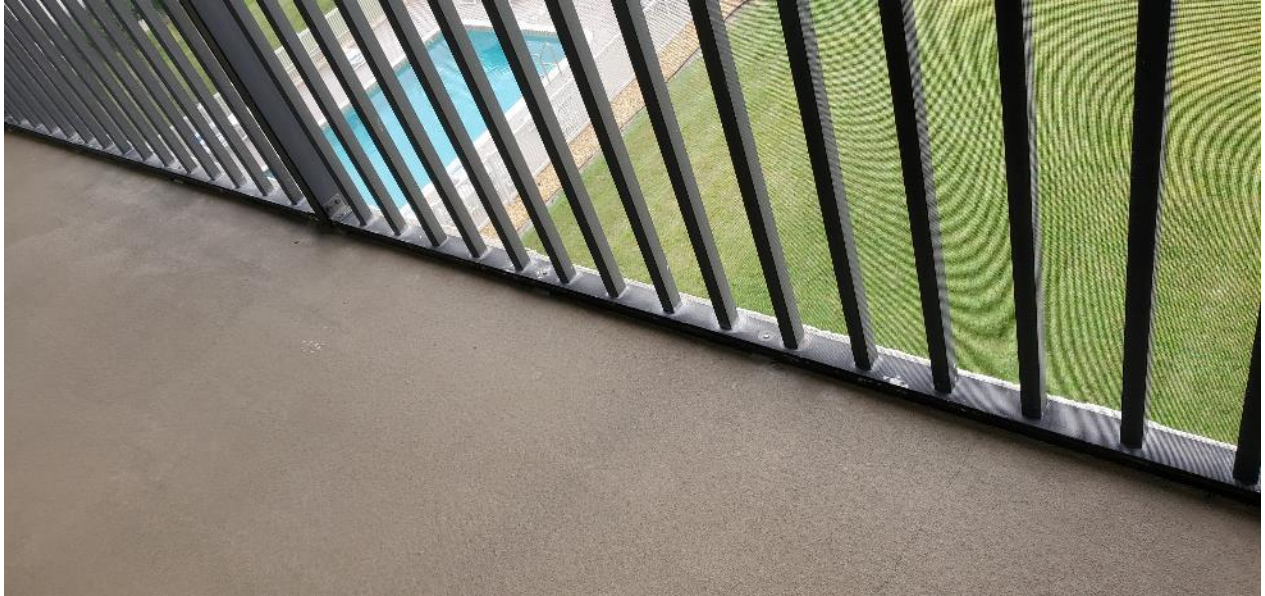
Enclosure/railing coating oxidizing and failing

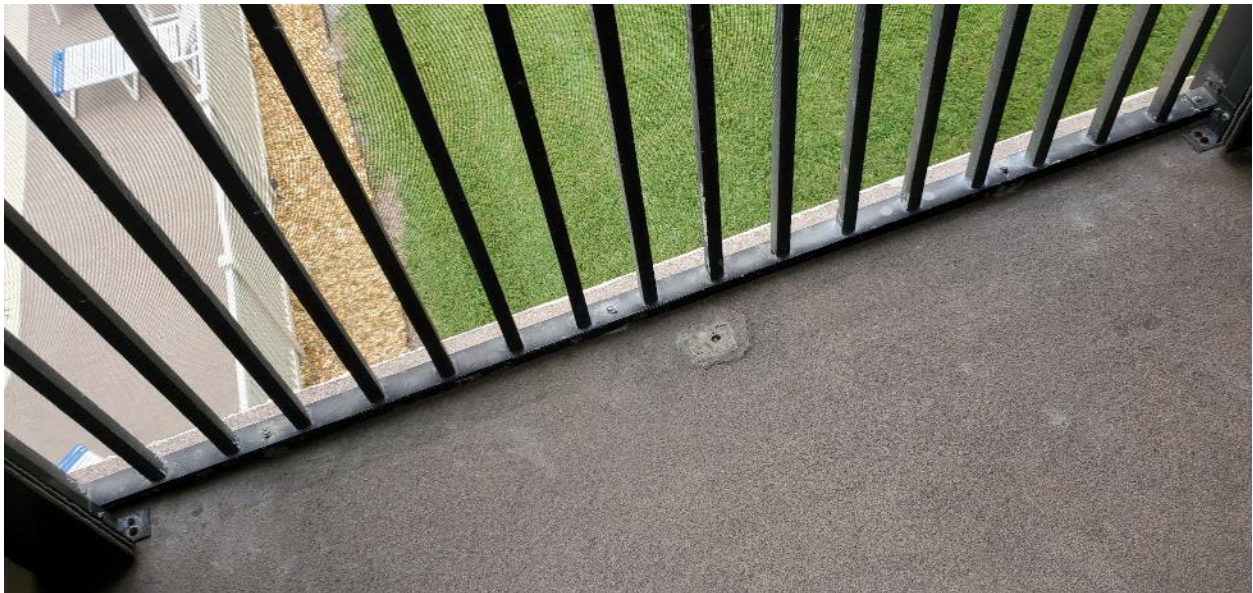
Enclosure/railing coating oxidizing and failing

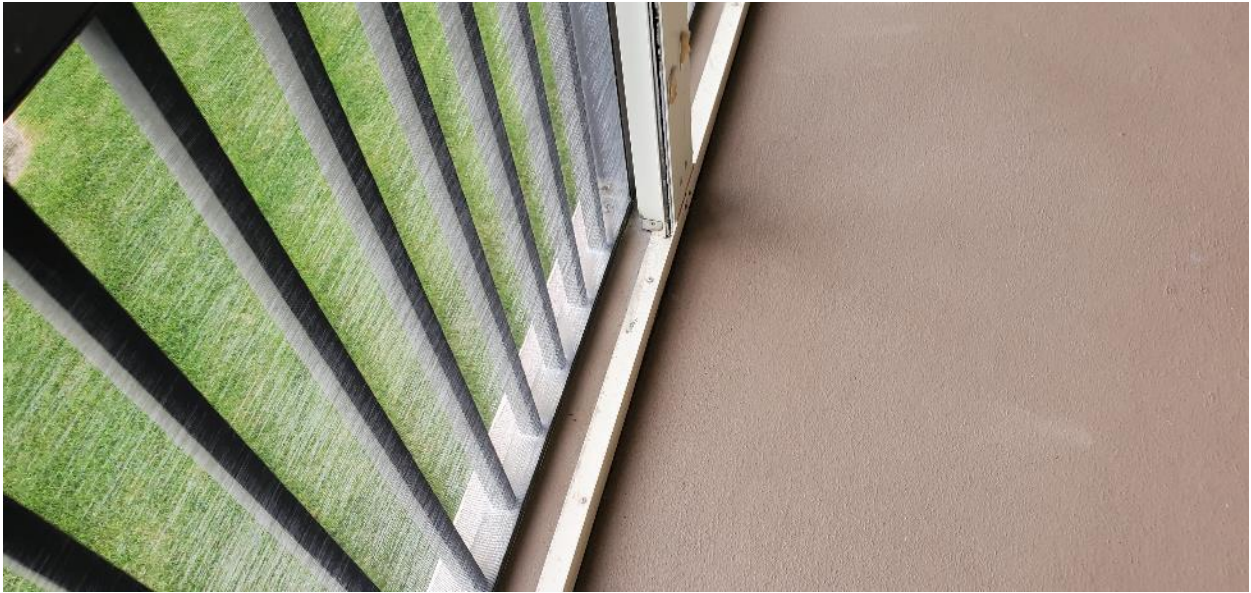
Shutters at balcony edge properly shimmed

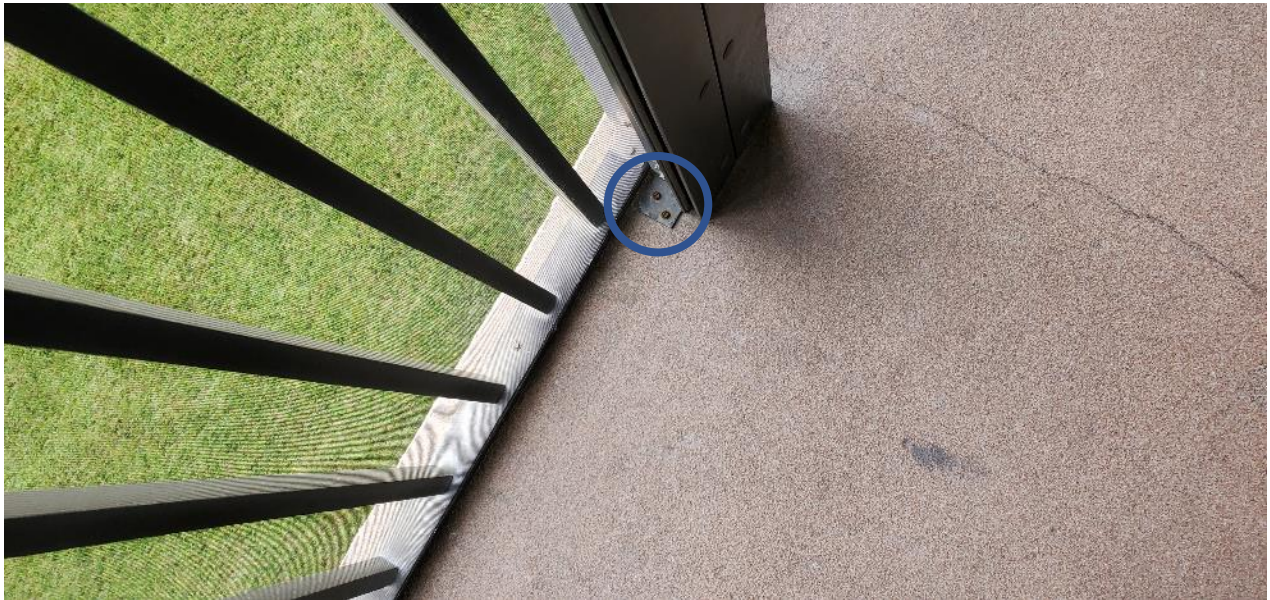
Corroded fasteners on shutter track

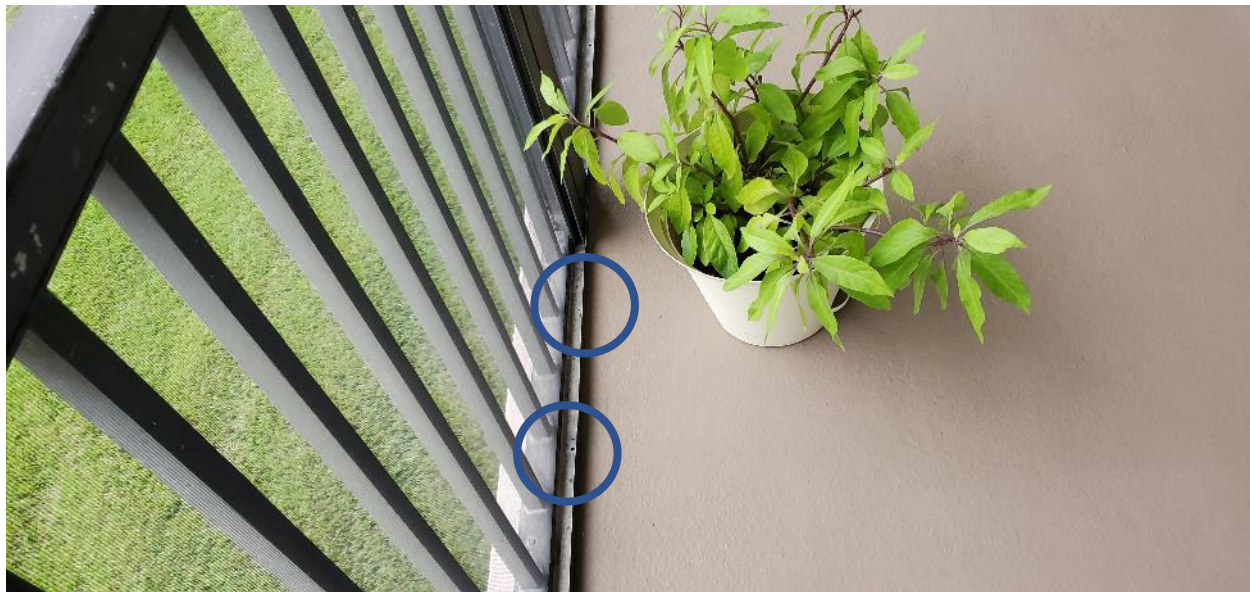
Corroded fasteners on shutter track

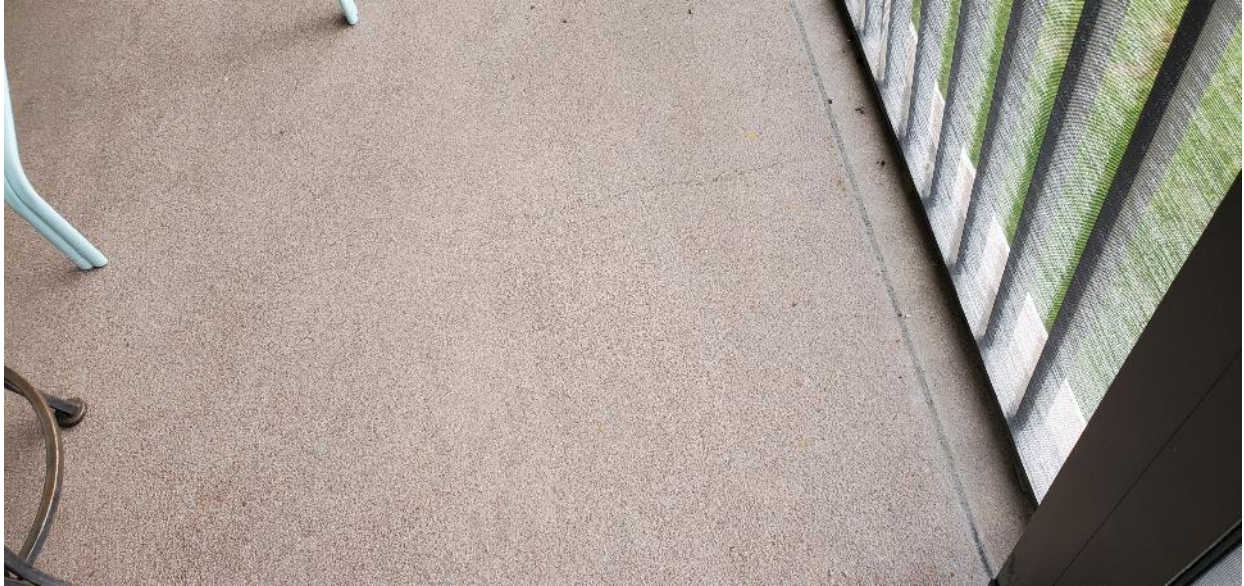
Cracks in balcony floor coating

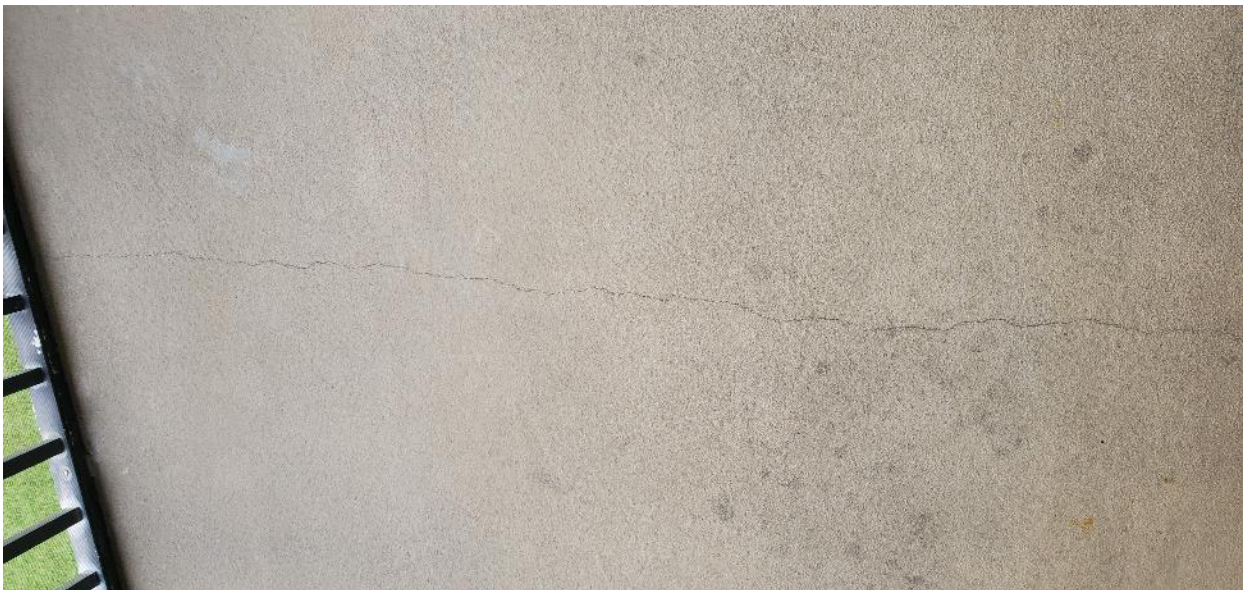
Cracks in balcony floor coating

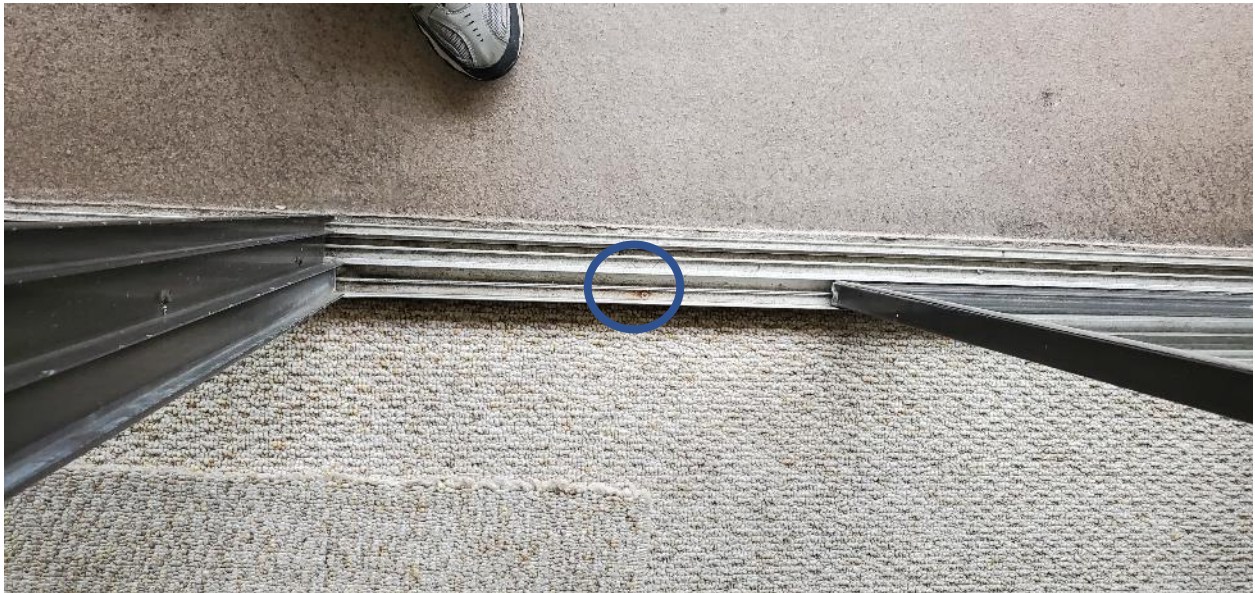
Corroded sliding glass door fasteners

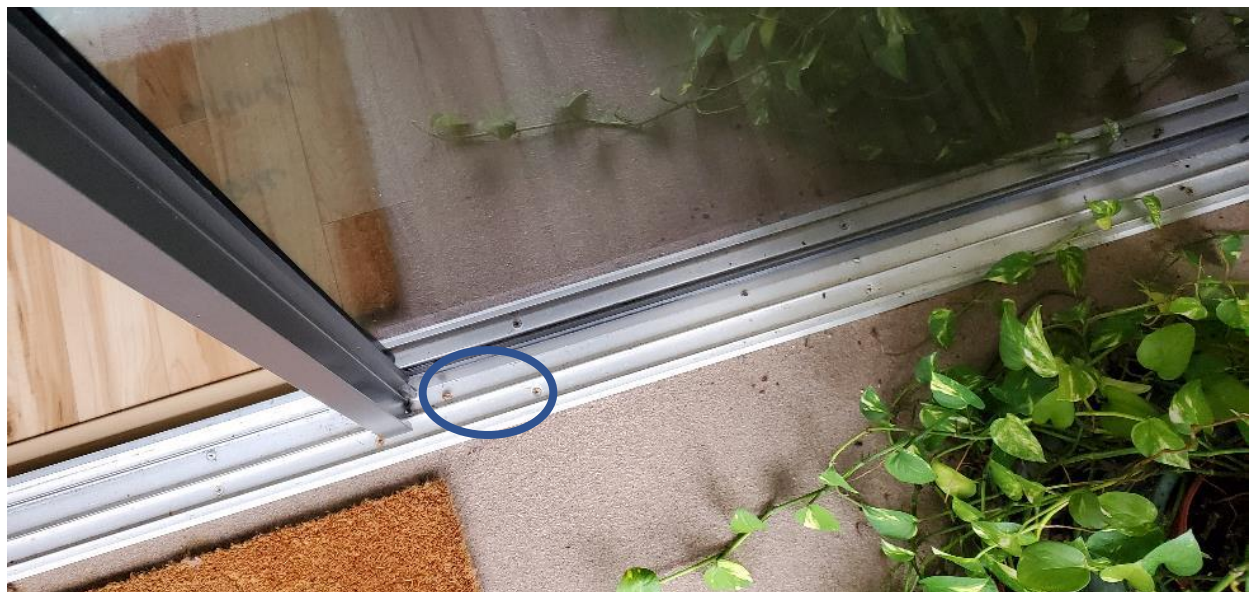
Corroded fasteners at sliding glass door

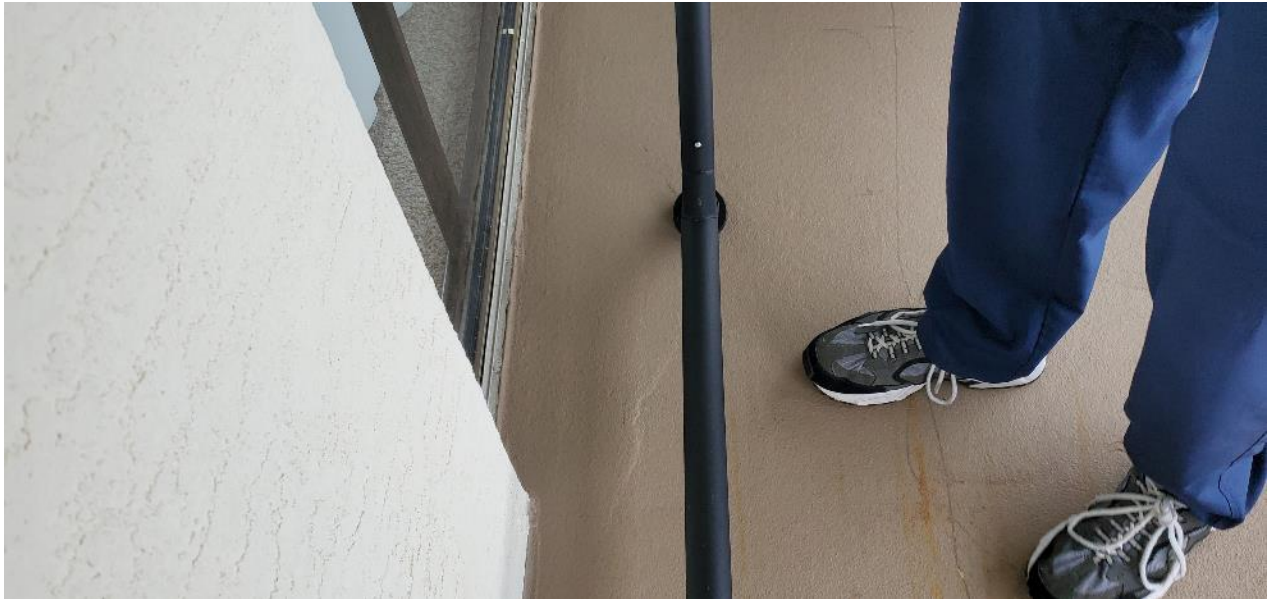
Concrete spall at sliding glass door caused by reinforcing steel corrosion

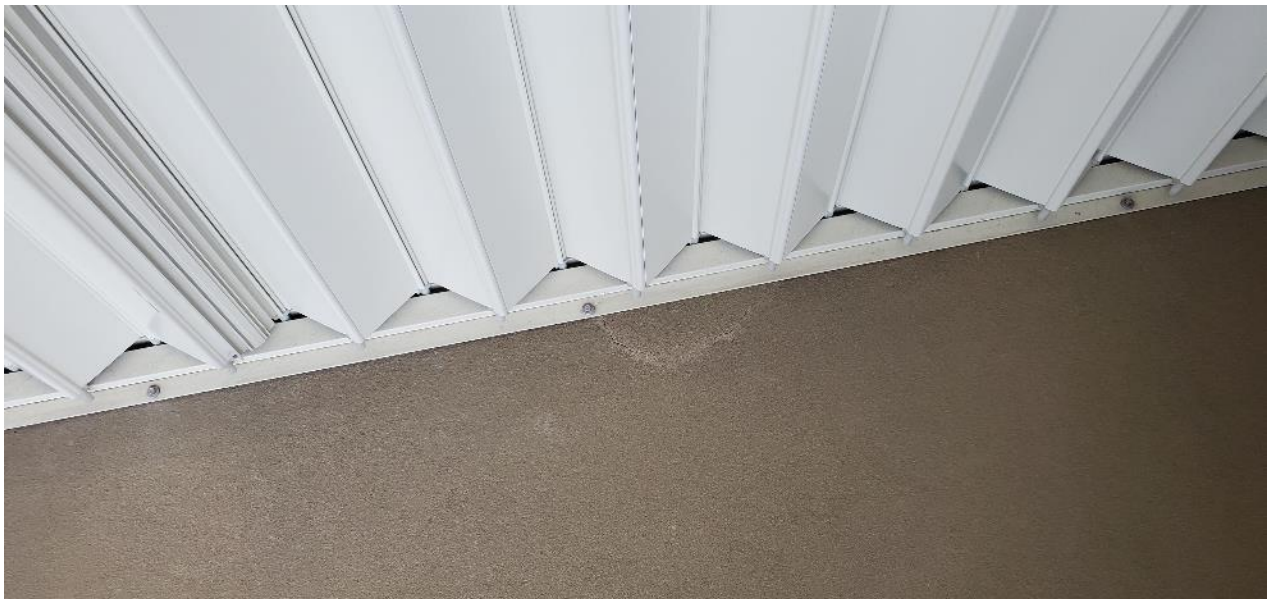
Concrete spall under shutter track caused by reinforcing steel corrosion

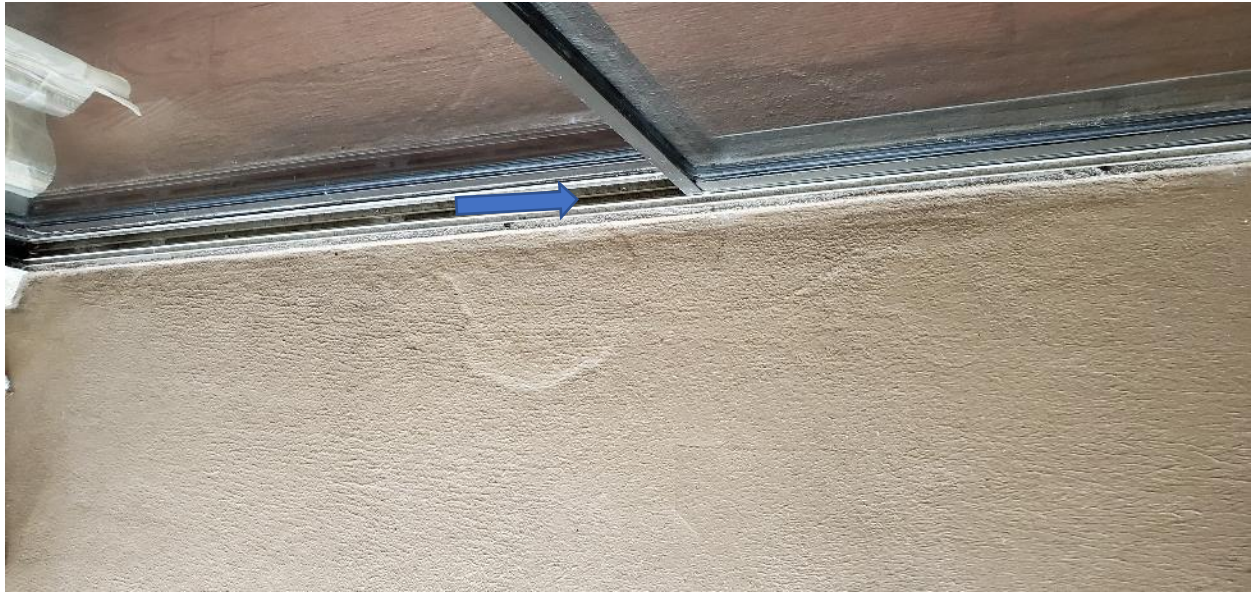
Concrete spall at sliding glass door caused by reinforcing steel corrosion

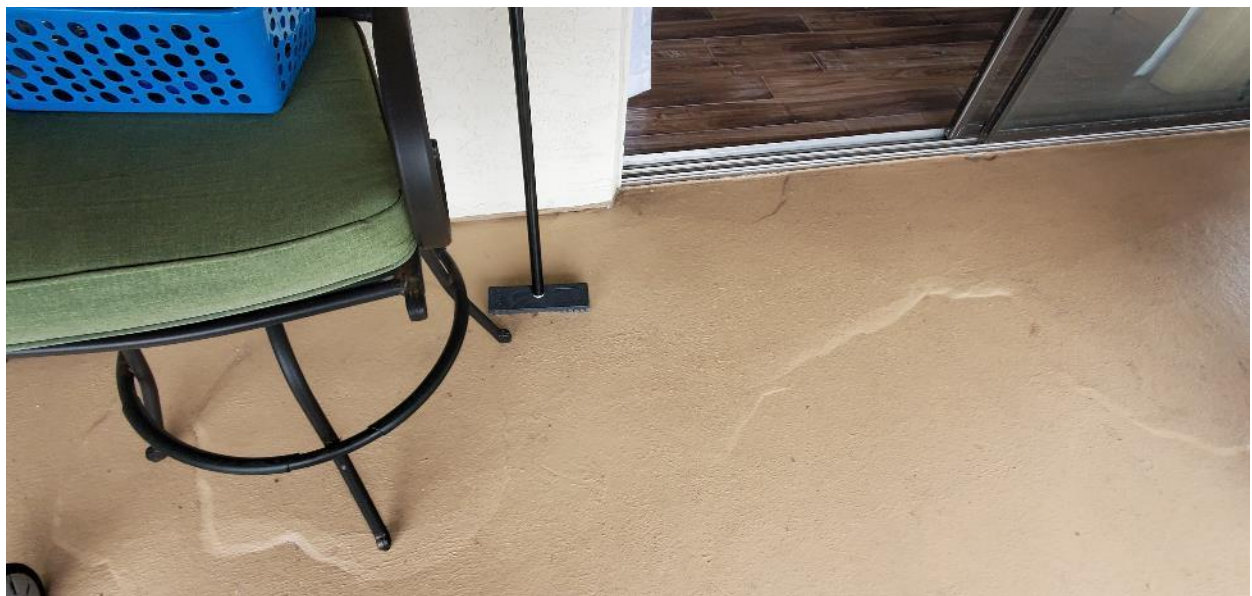
Concrete spall at sliding glass door caused by reinforcing steel corrosion

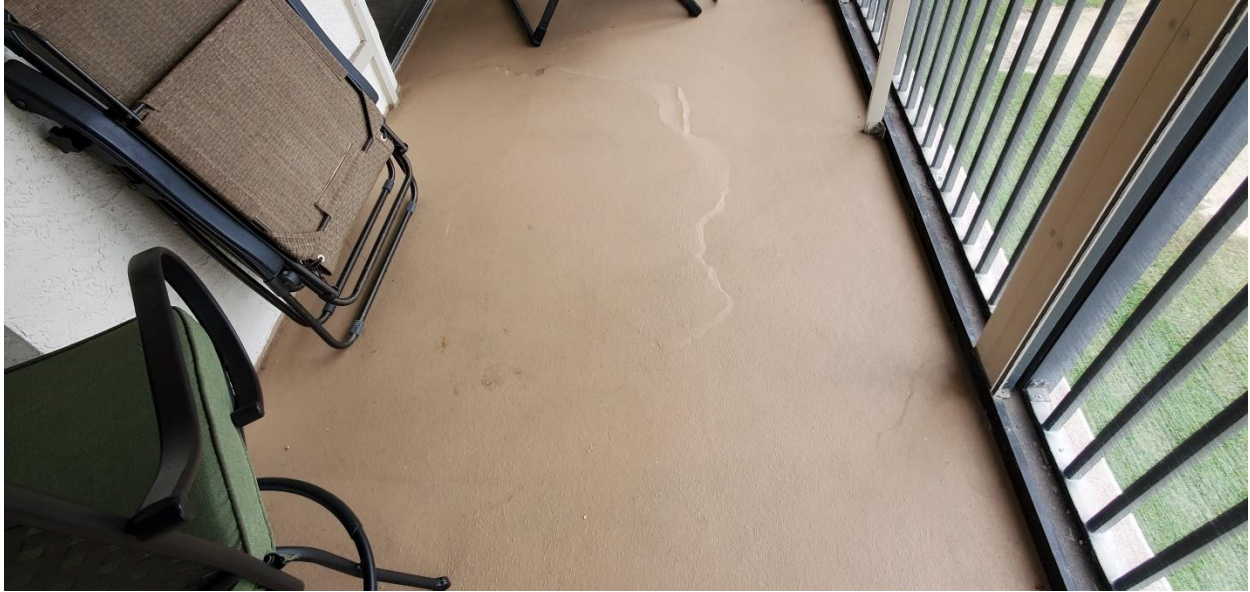
Concrete spall caused by reinforcing steel corrosion

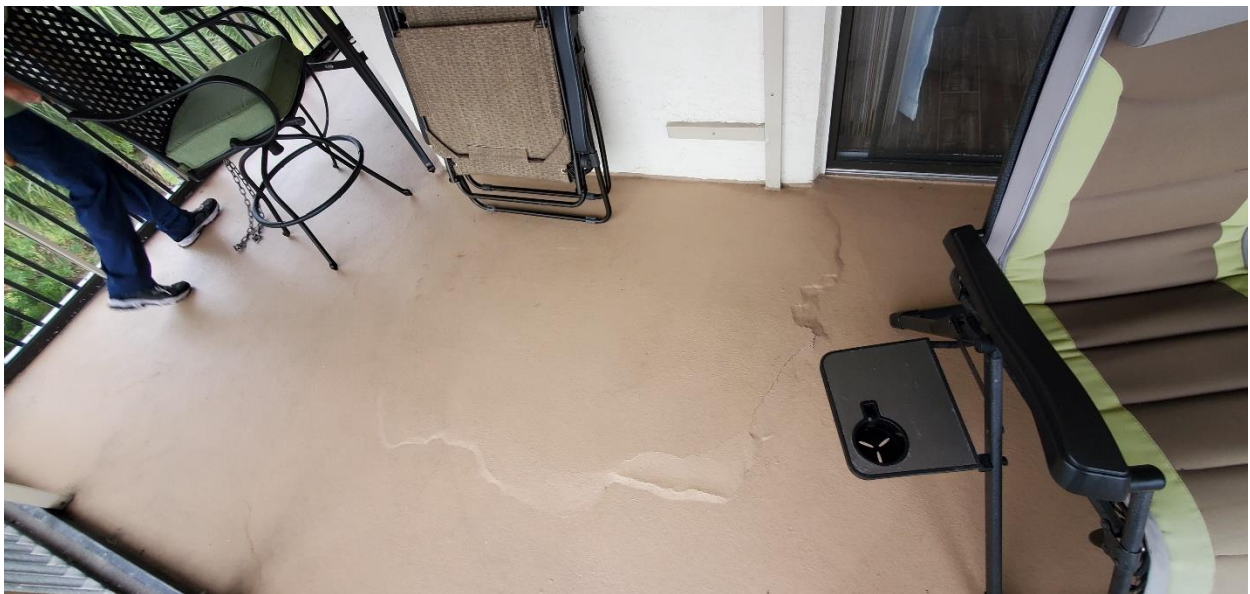
Concrete spall caused by reinforcing steel corrosion

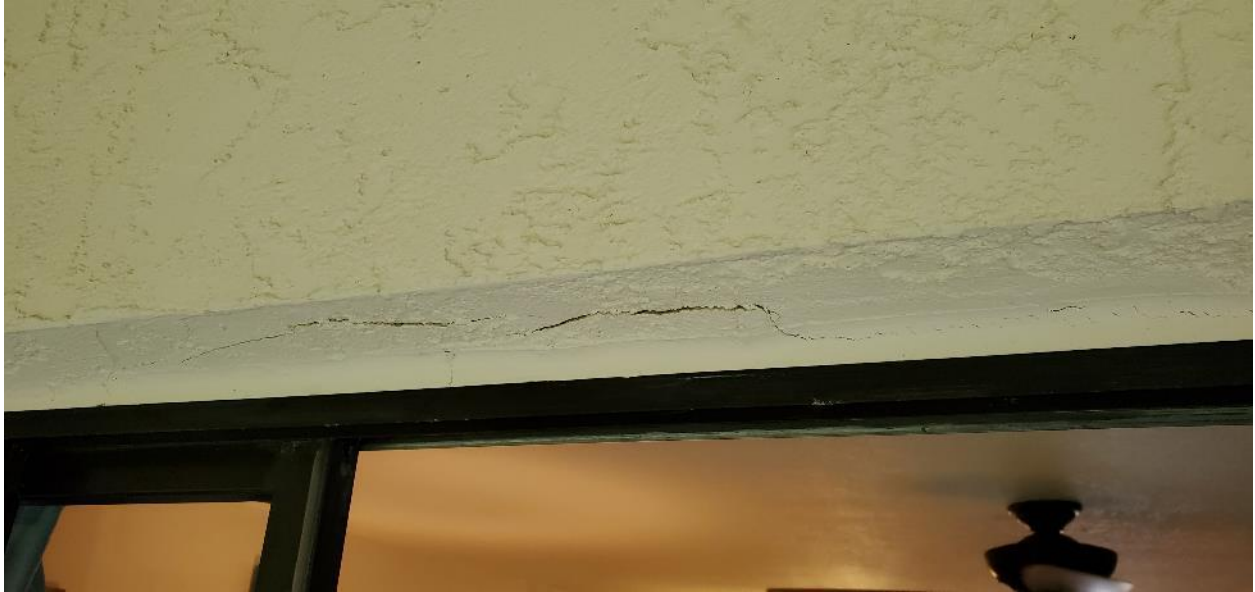
Cracks at sliding glass door header

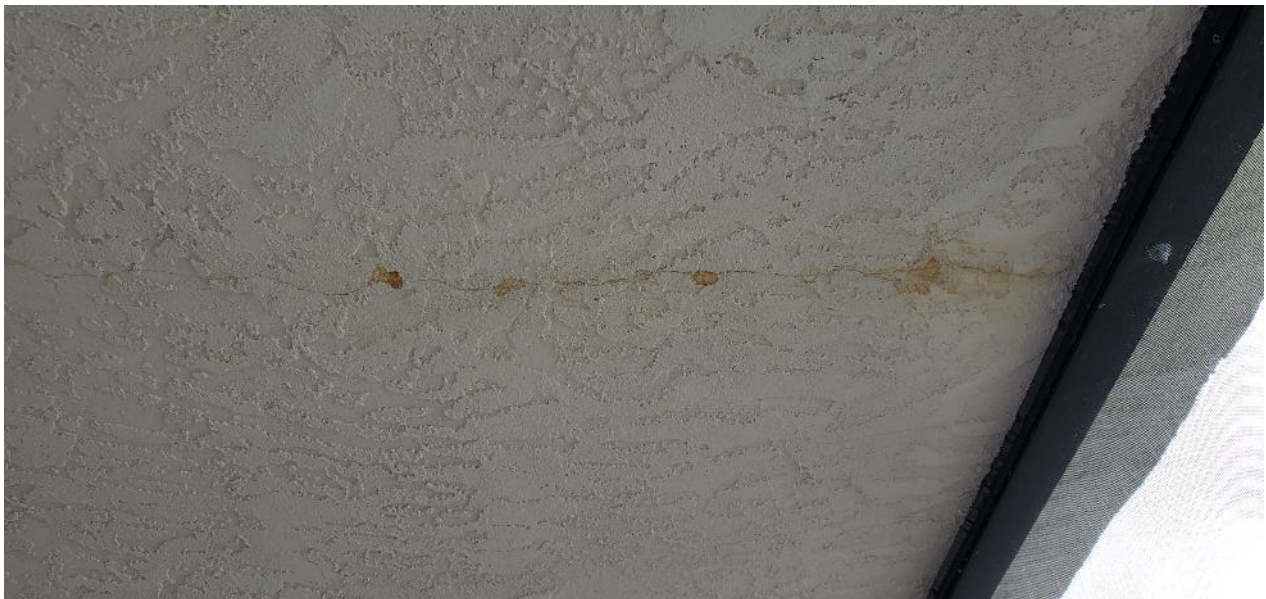
Cracks and rust spots on ceiling surface

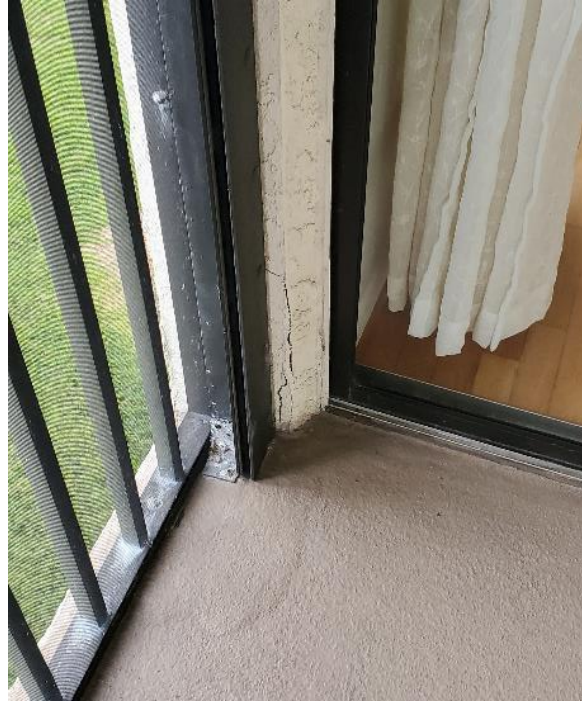
Column spall and edge spall caused by reinforcing steel corrosion

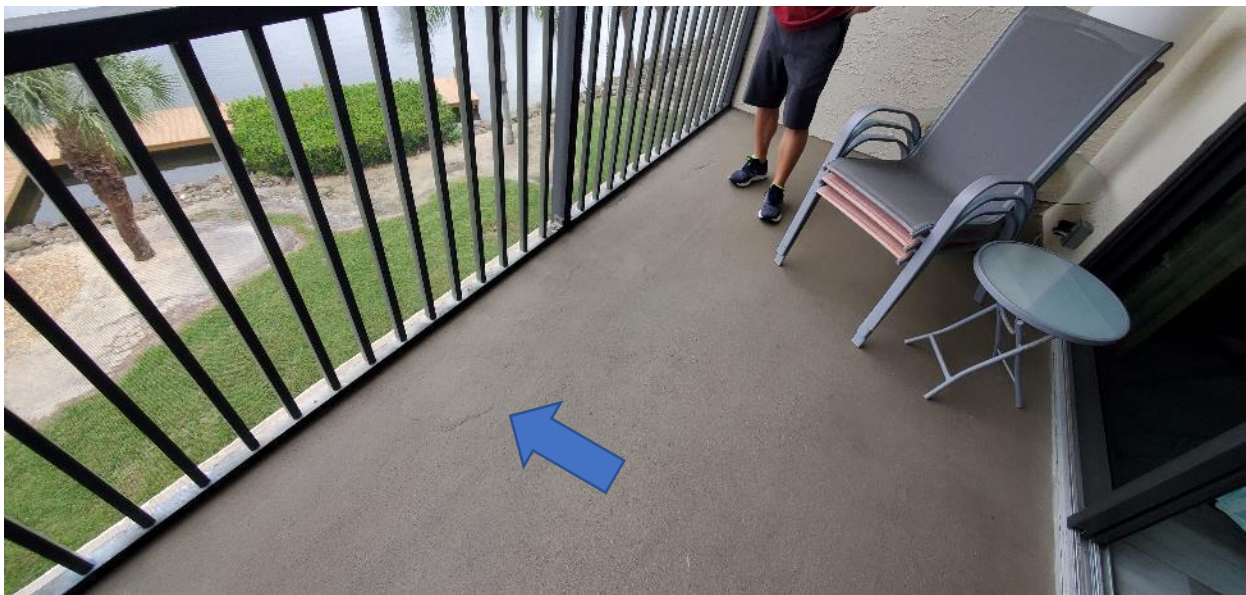
Spalls along balcony slab edge, caused by reinforcing steel corrosion

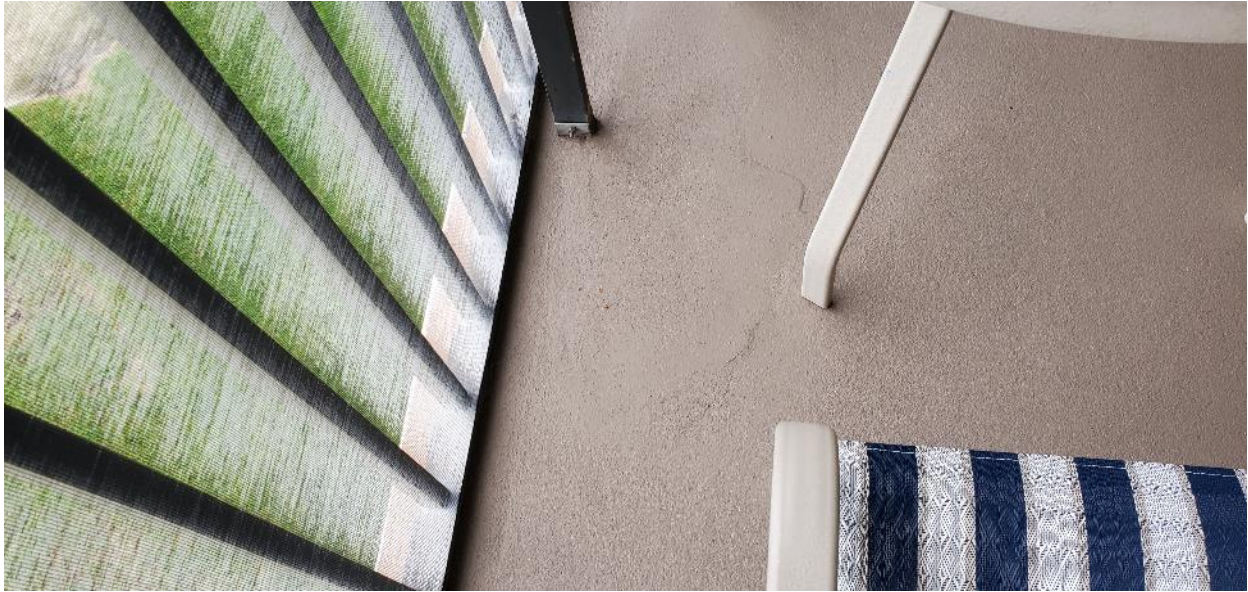
Spall along balcony slab edge, caused by reinforcing steel corrosion

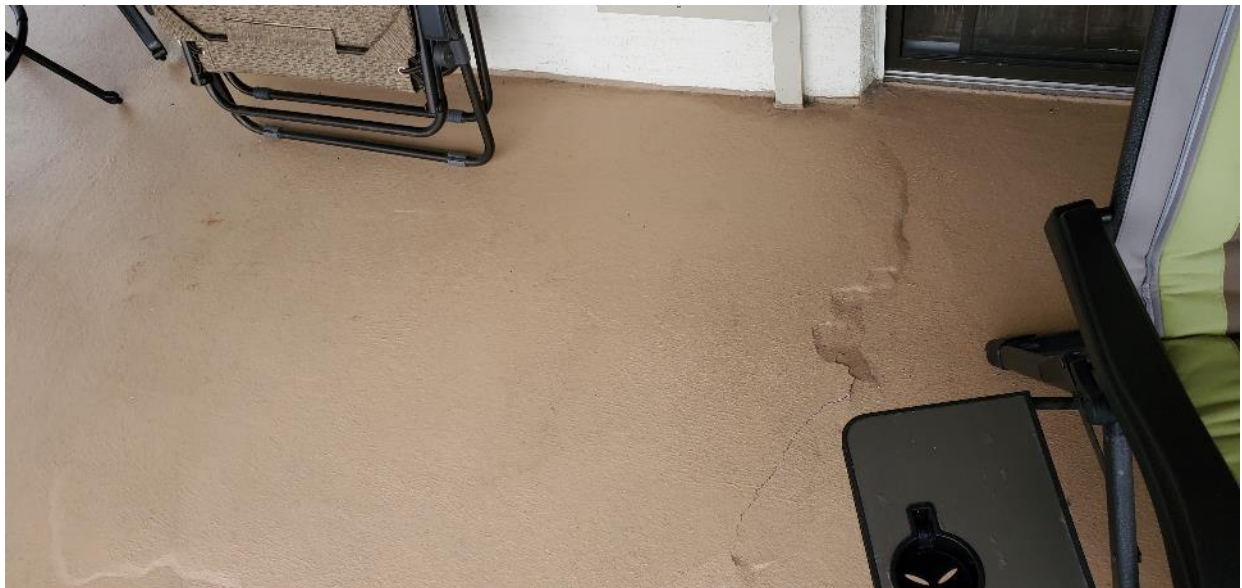
Advanced spall caused by reinforcing steel corrosion

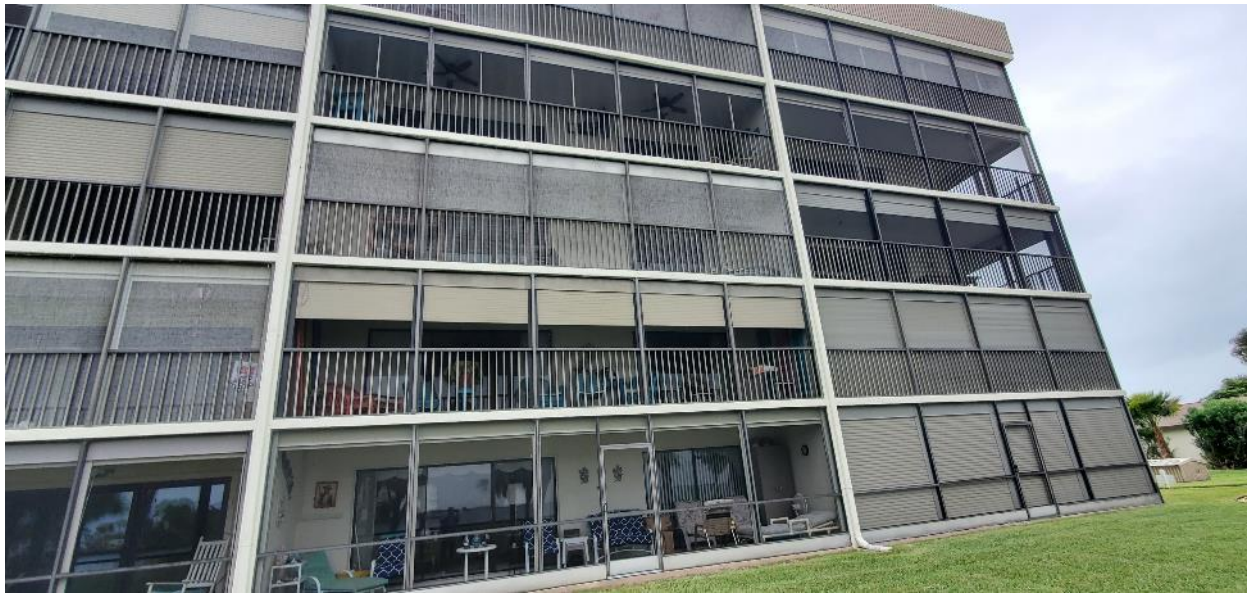
Overview of west elevation

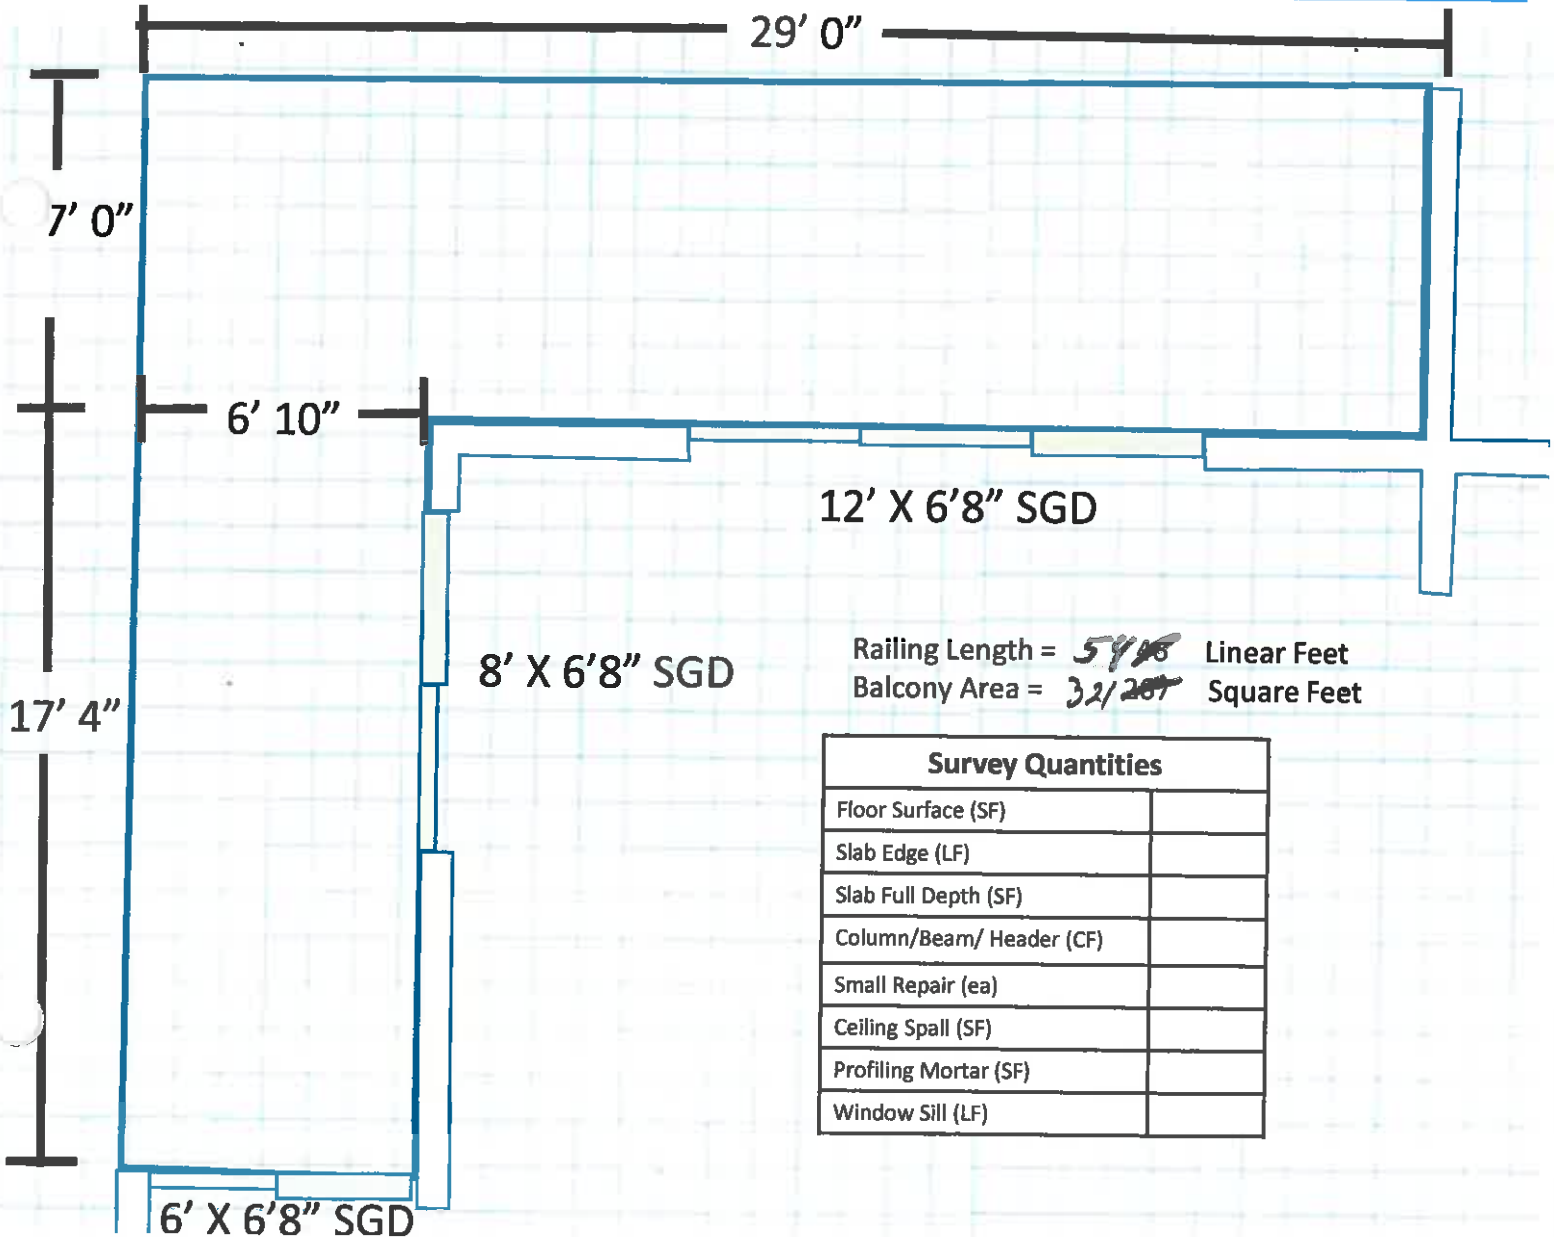
Survey Quantities	
Floor Surface (SF)	
Slab Edge (LF)	
Slab Full Depth (SF)	
Column/Beam/ Header (CF)	
Small Repair (ea)	
Ceiling Spall (SF)	
Profiling Mortar (SF)	
Window Sill (LF)

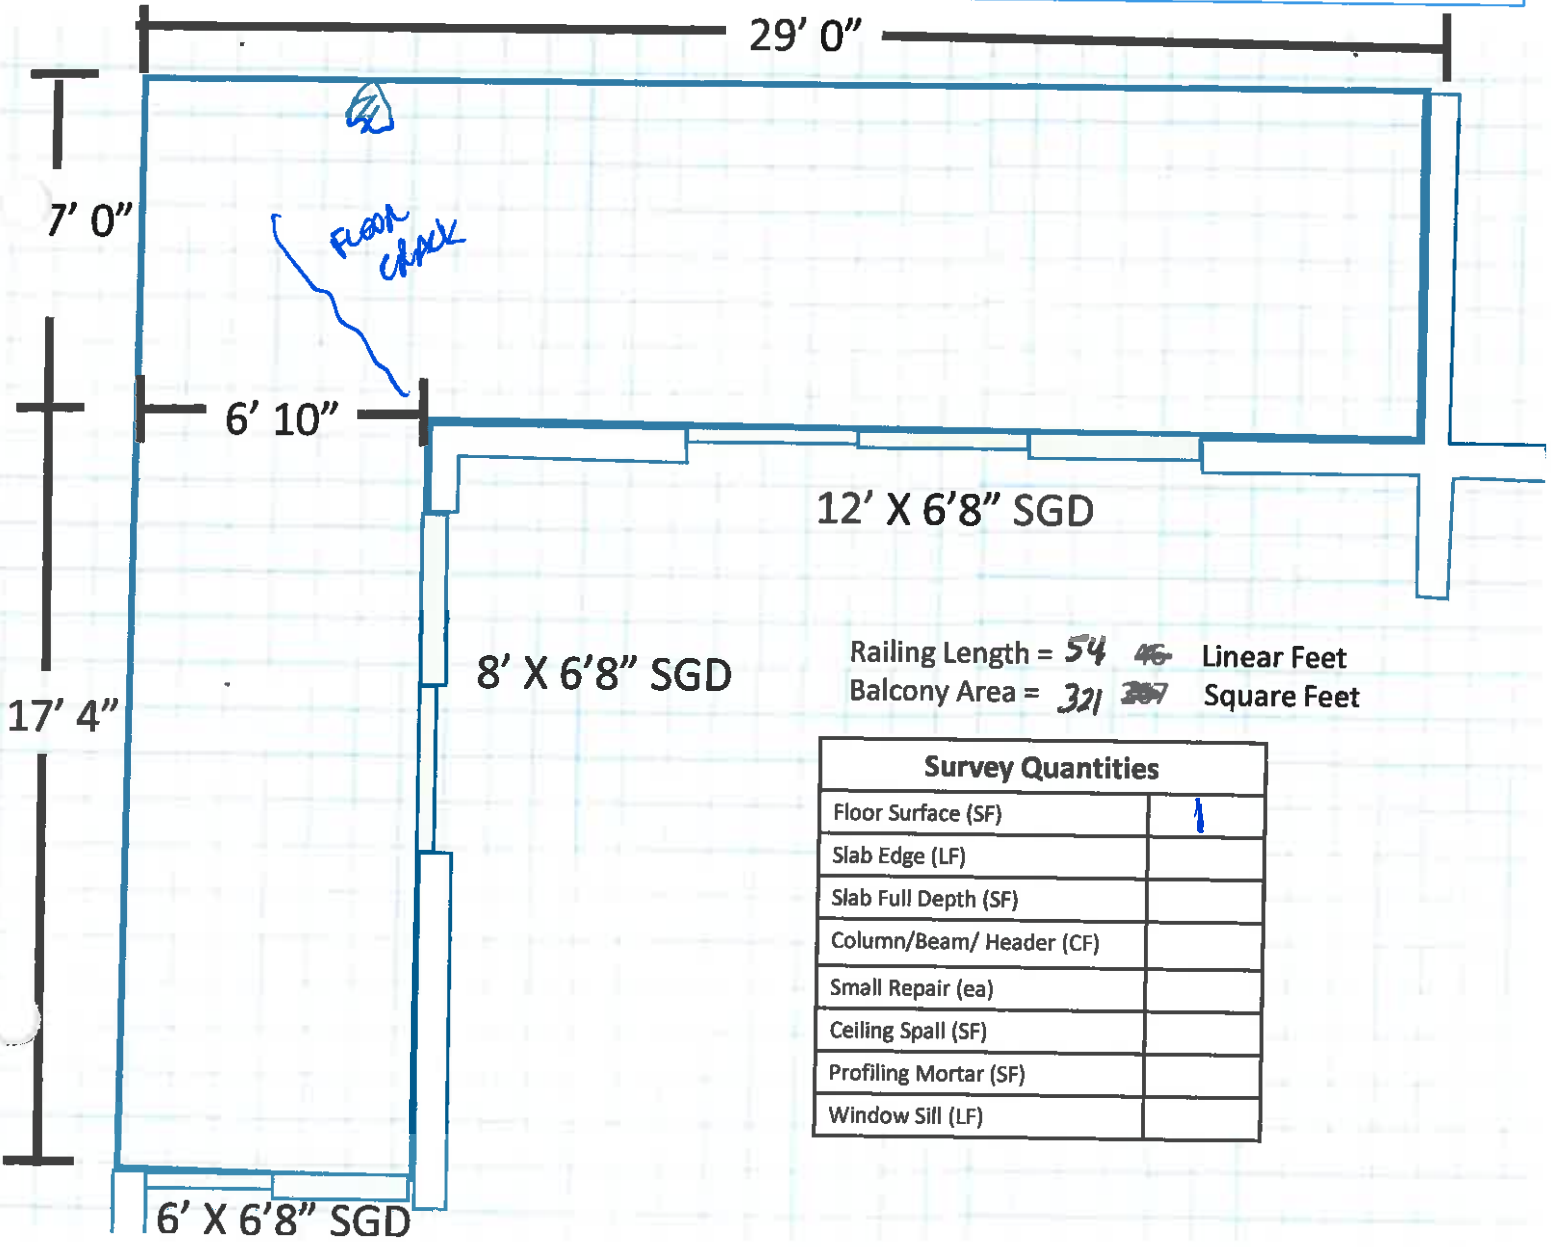
Survey Quantities	
Floor Surface (SF)	1
Slab Edge (LF)	
Slab Full Depth (SF)	
Column/Beam/ Header (CF)	
Small Repair (ea)	
Ceiling Spall (SF)	
Profiling Mortar (SF)	
Window Sill (LF)
