Sunset Harbor Condominium

3873 South Banana River Boulevard
Cocoa Beach, Florida 32931

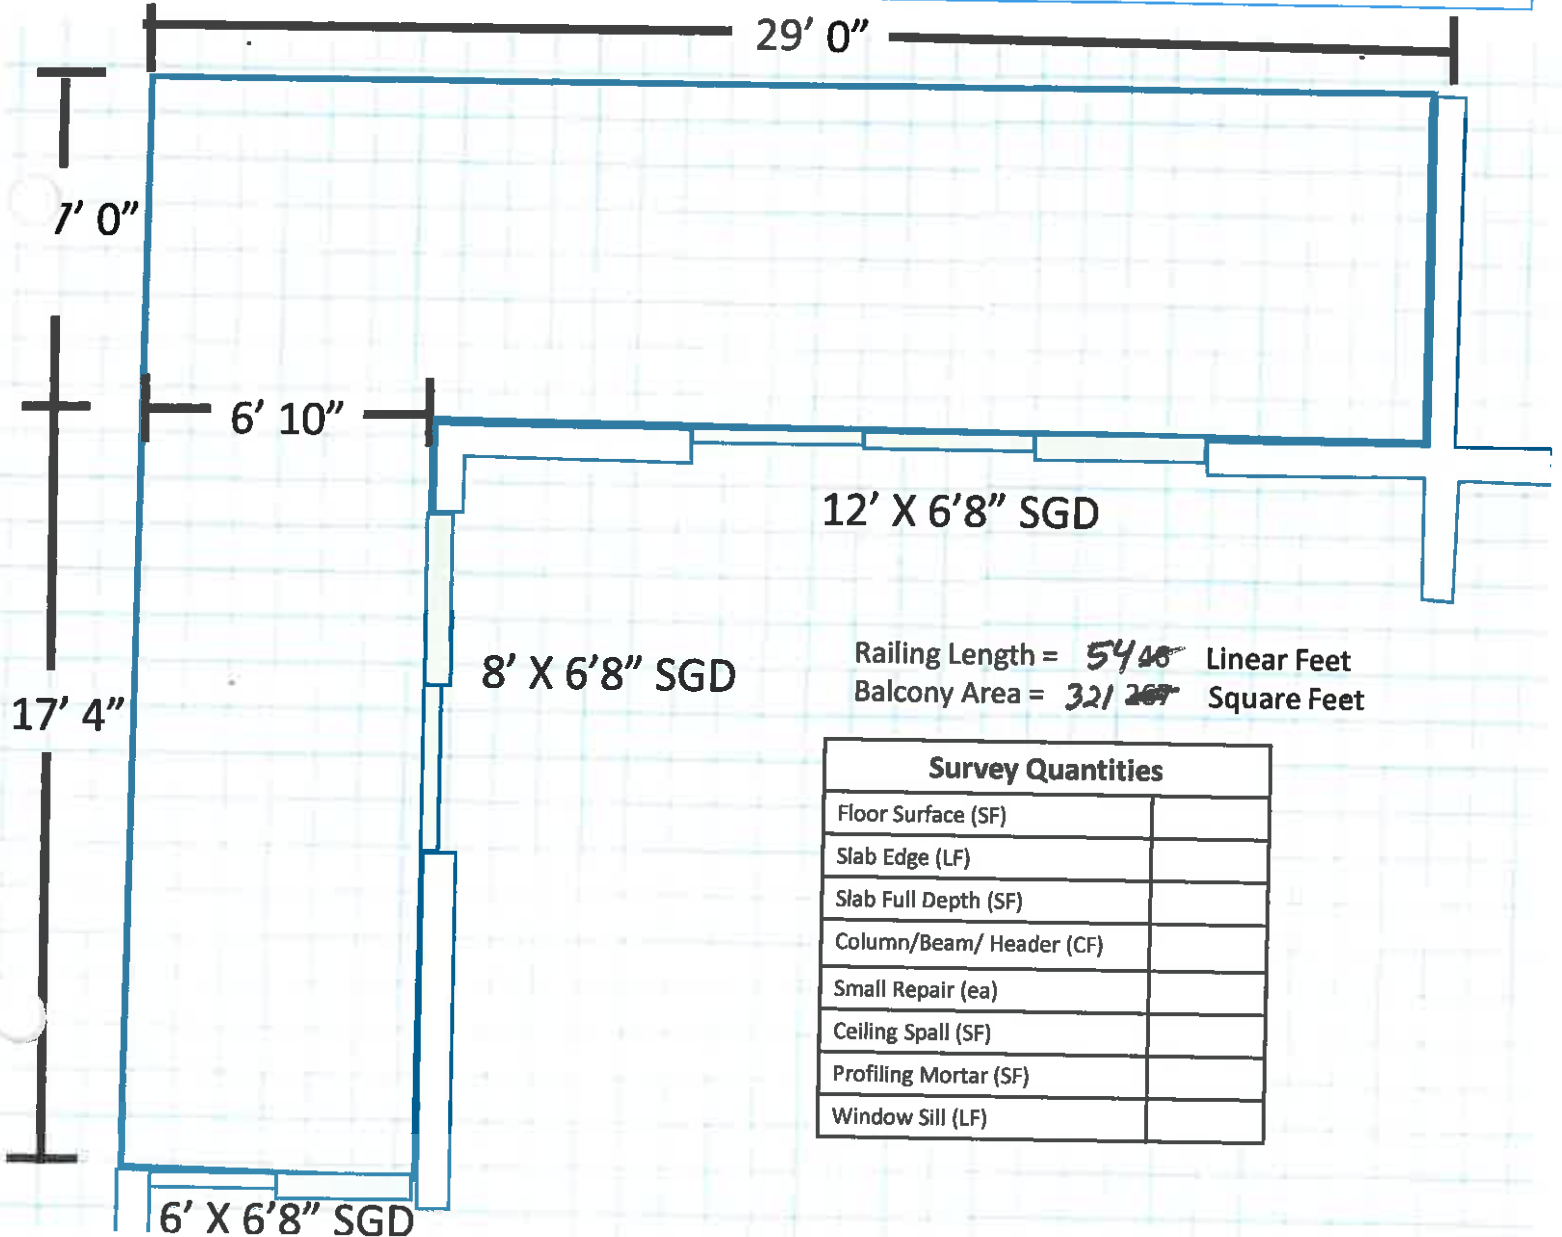
Survey Quantities	
Floor Surface (SF)	
Slab Edge (LF)	
Slab Full Depth (SF)	
Column/Beam/ Header (CF)	
Small Repair (ea)	
Ceiling Spall (SF)	
Profiling Mortar (SF)	
Window Sill (LF)

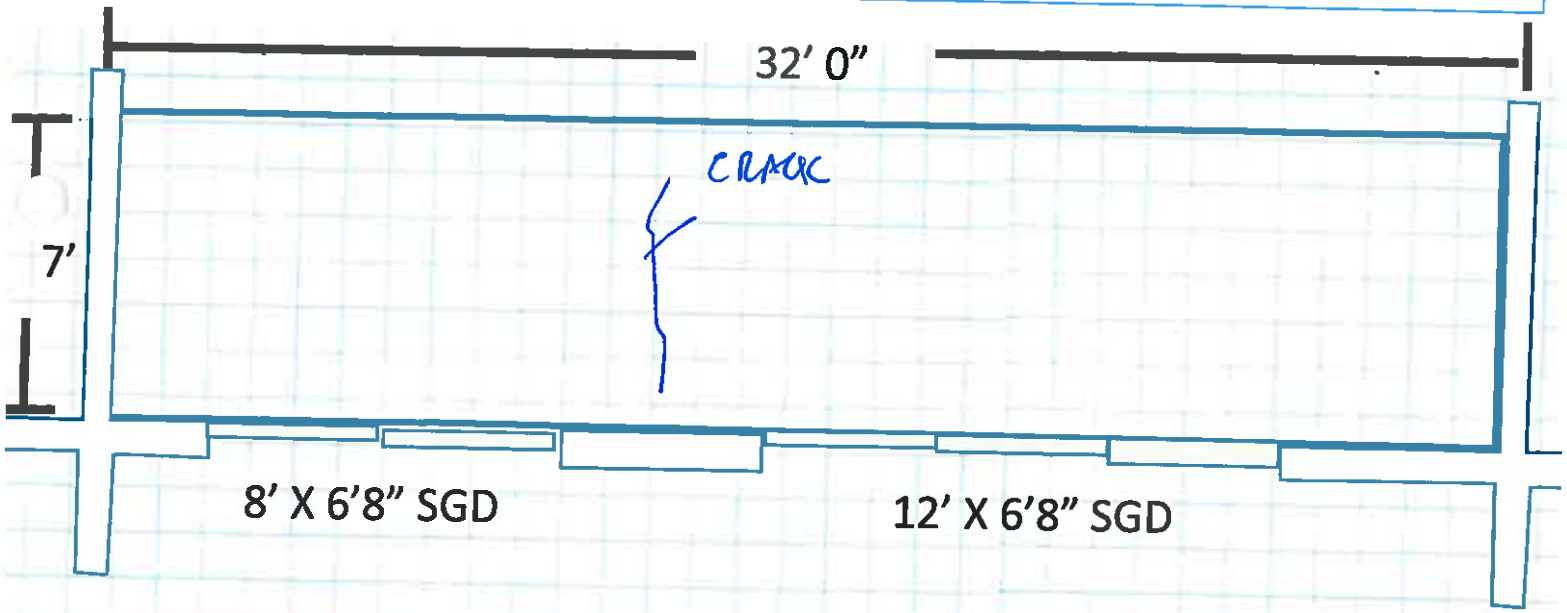
Railing Length = 32 Linear Feet
Balcony Area = 224 Square Feet

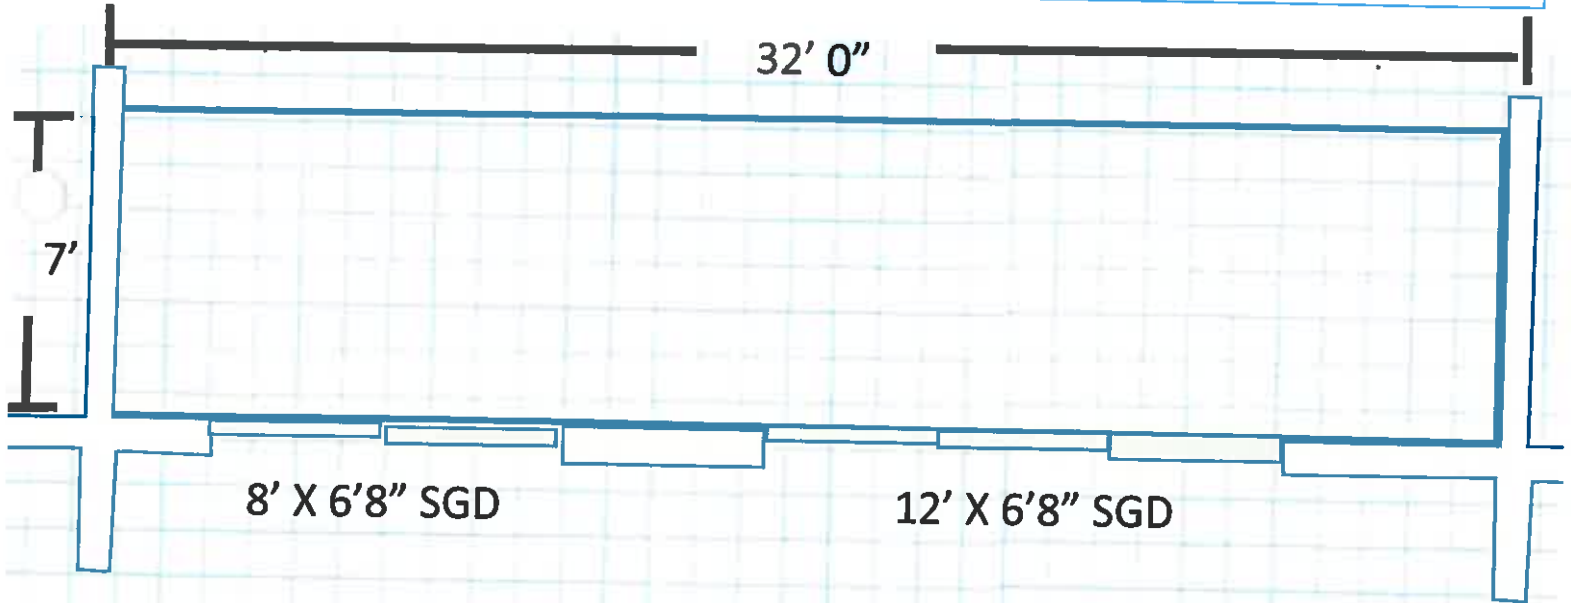
Railing Length = ~~32~~ 32 Linear Feet
Balcony Area = ~~214~~ 224 Square Feet

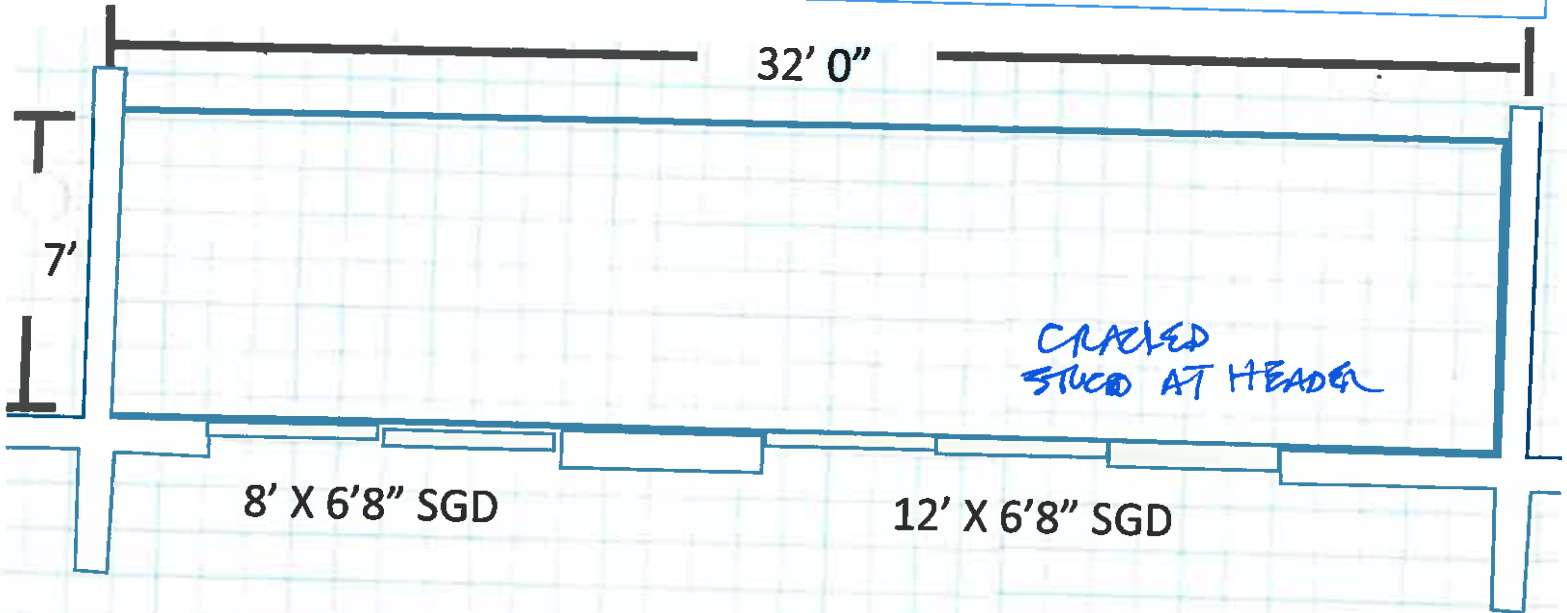
Railing Length = 32 ~~45~~ Linear Feet
Balcony Area = 224 ~~207~~ Square Feet

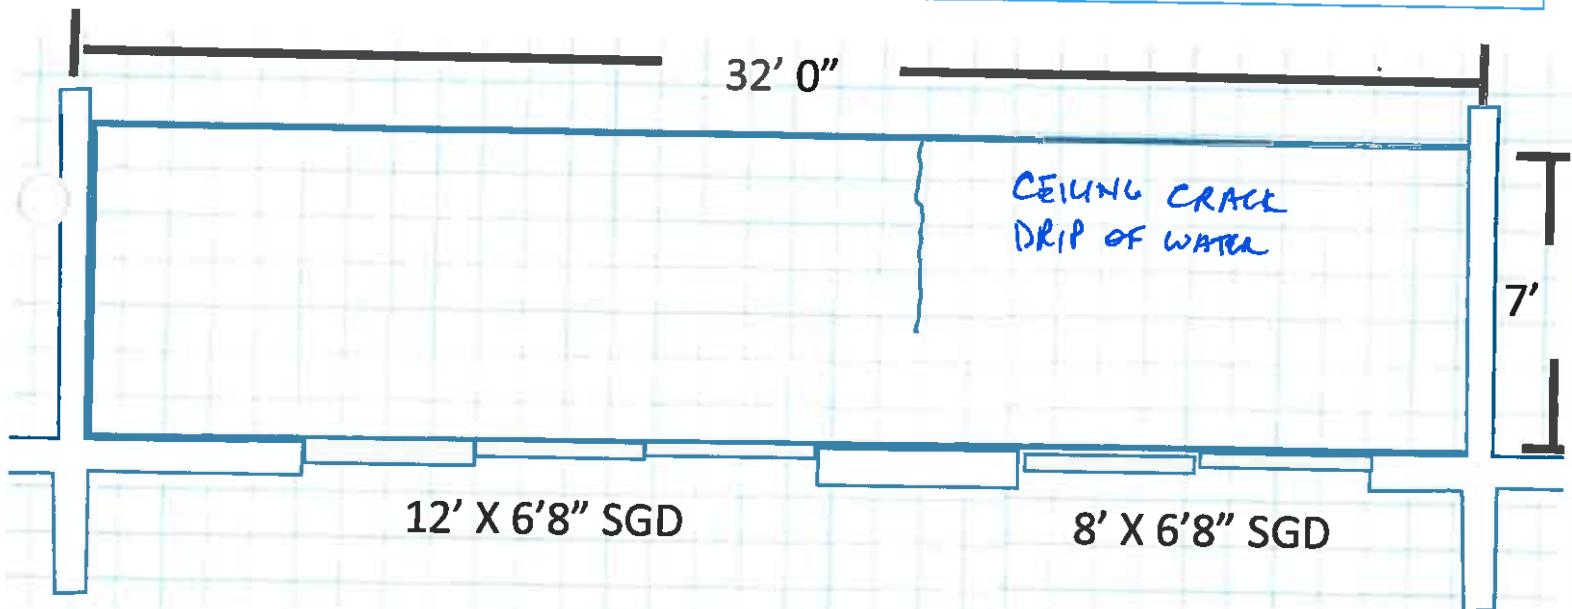
Railing Length = 32 Linear Feet
Balcony Area = 224 Square Feet

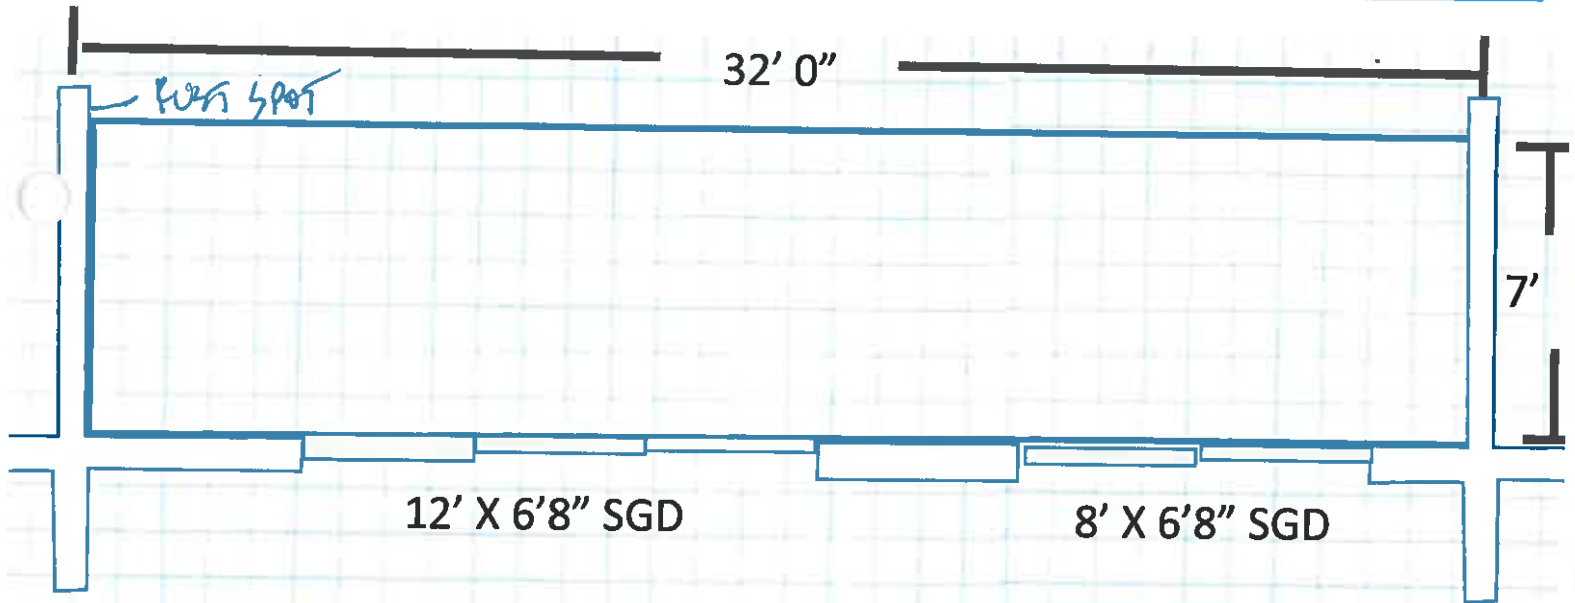
Railing Length = 32 ~~4~~ Linear Feet
Balcony Area = 224 ~~207~~ Square Feet

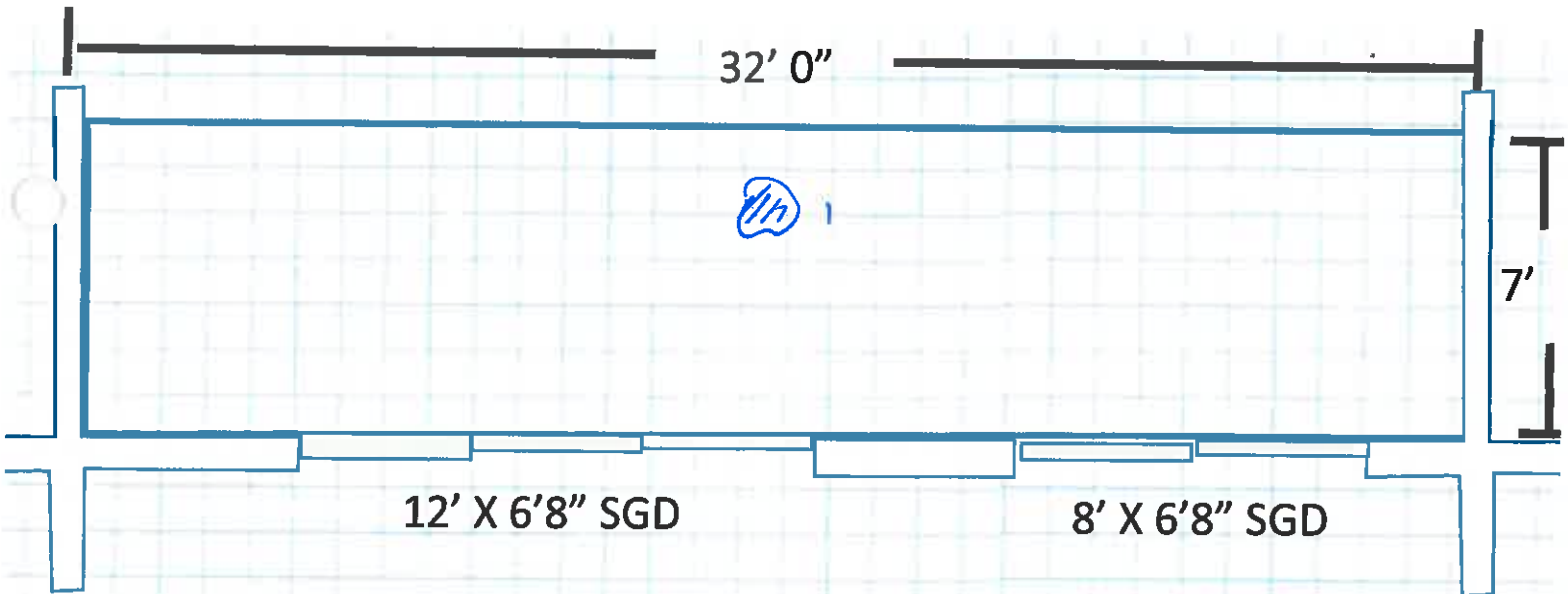
Railing Length = 32 Linear Feet
Balcony Area = 224 Square Feet

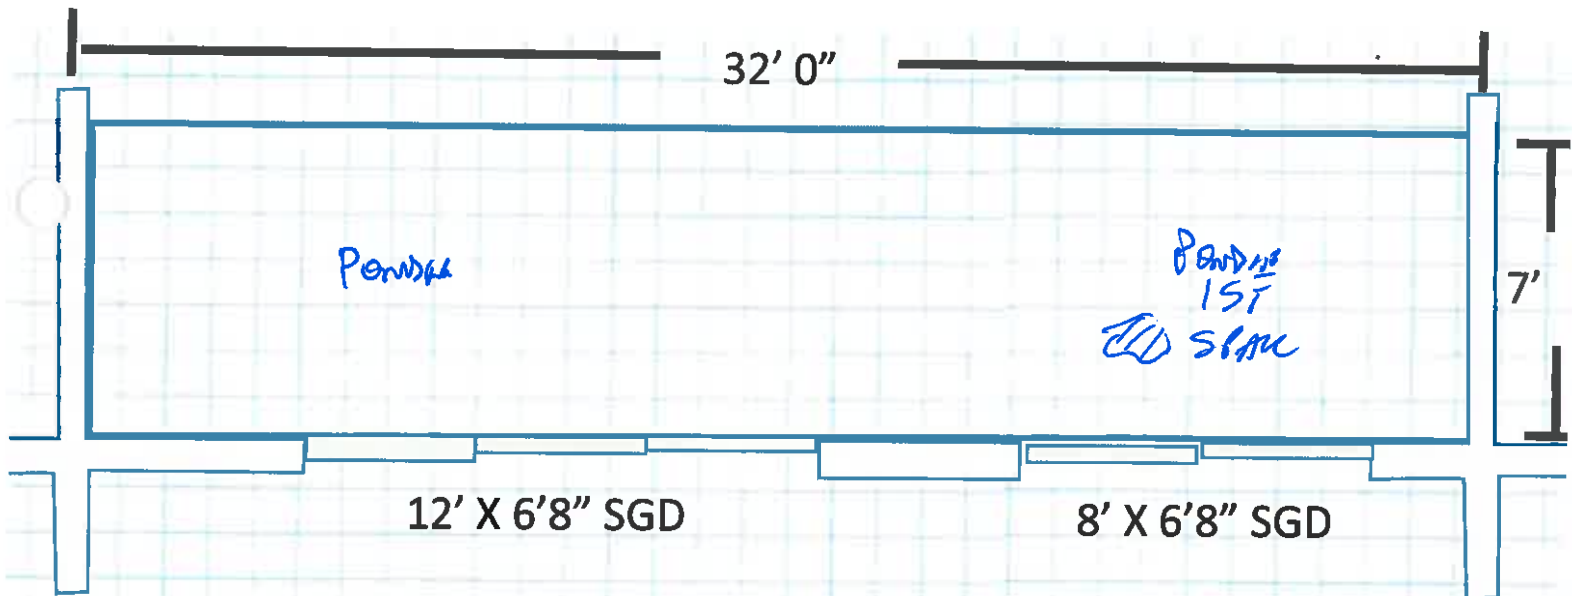
Railing Length = 32 Linear Feet
Balcony Area = 224 Square Feet

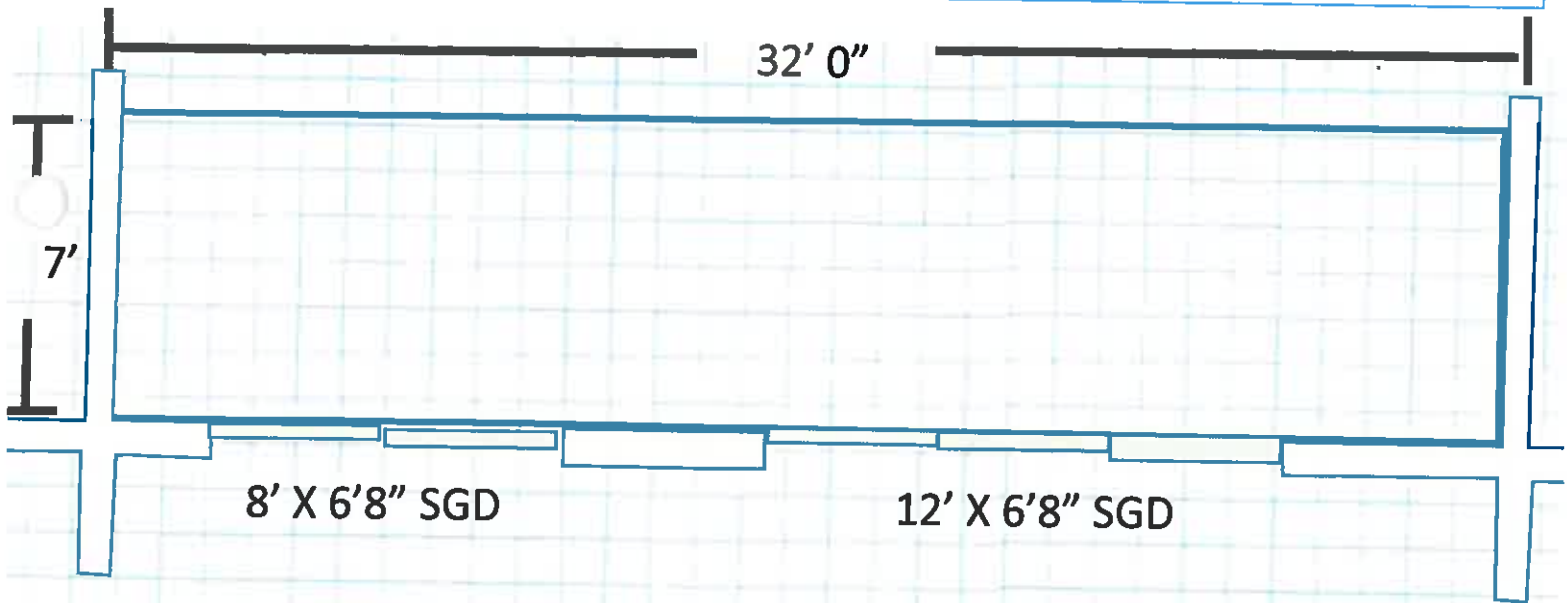
Railing Length = 32 Linear Feet
Balcony Area = 224 Square Feet

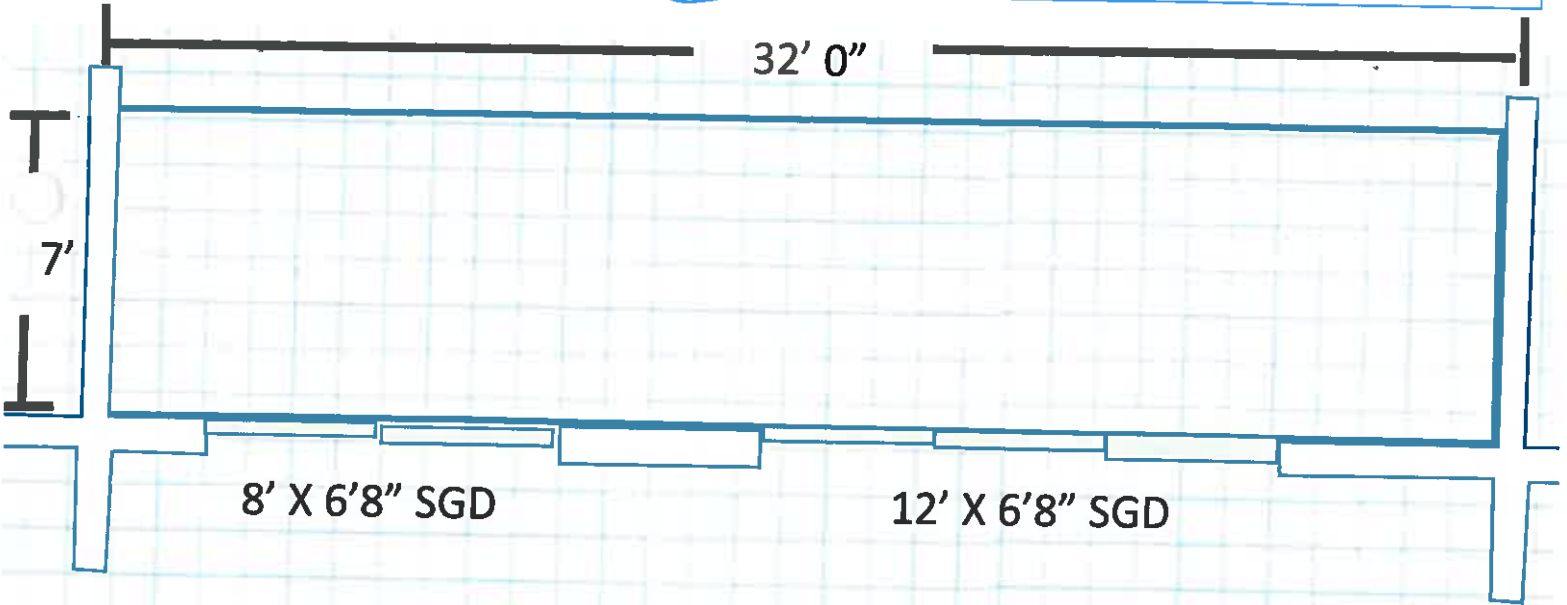
Railing Length = 32 Linear Feet
Balcony Area = 224 Square Feet

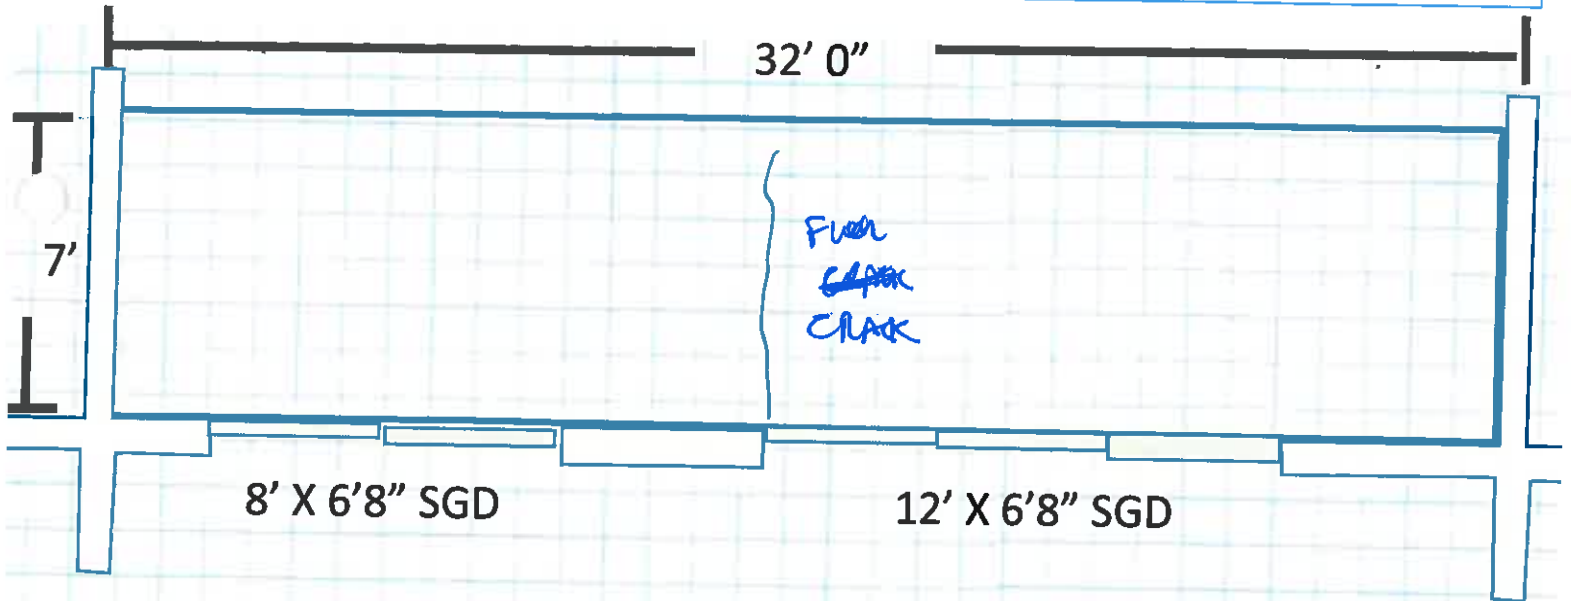
Railing Length = 32 Linear Feet
Balcony Area = 224 Square Feet

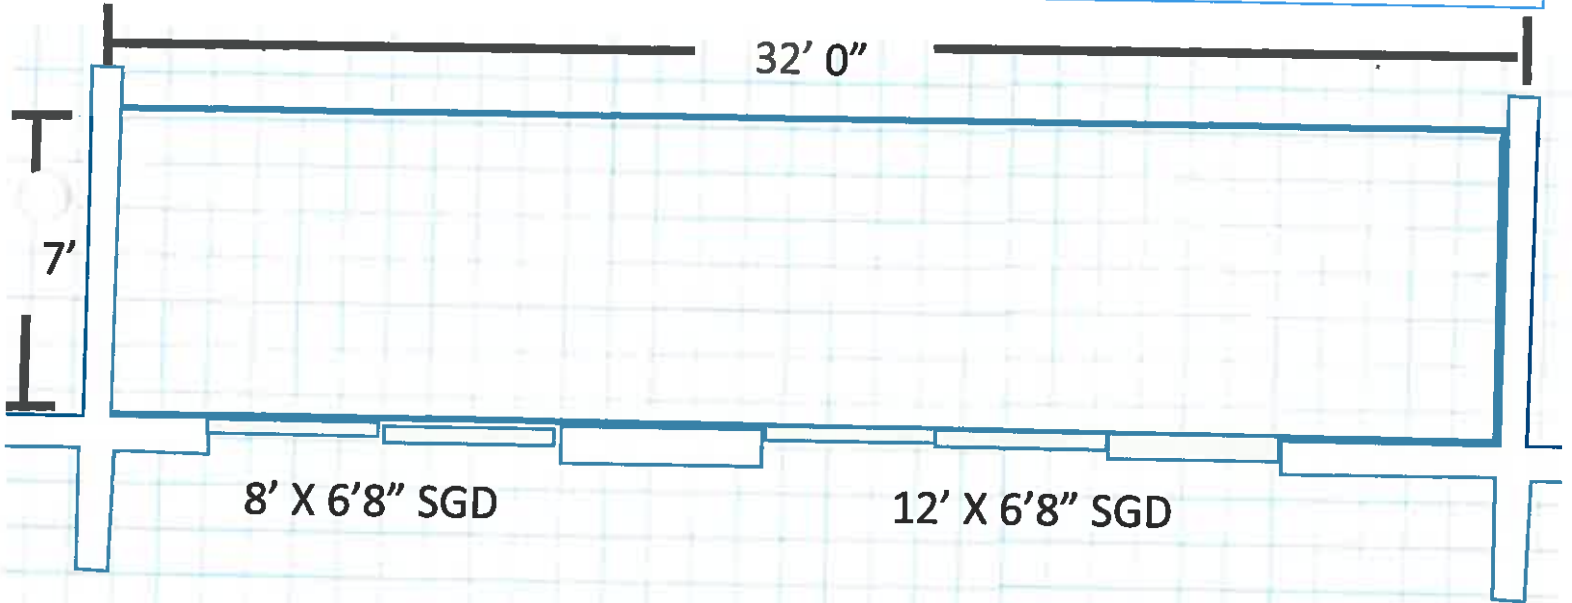
Railing Length = 32 ~~46~~ Linear Feet
Balcony Area = 224 ~~287~~ Square Feet

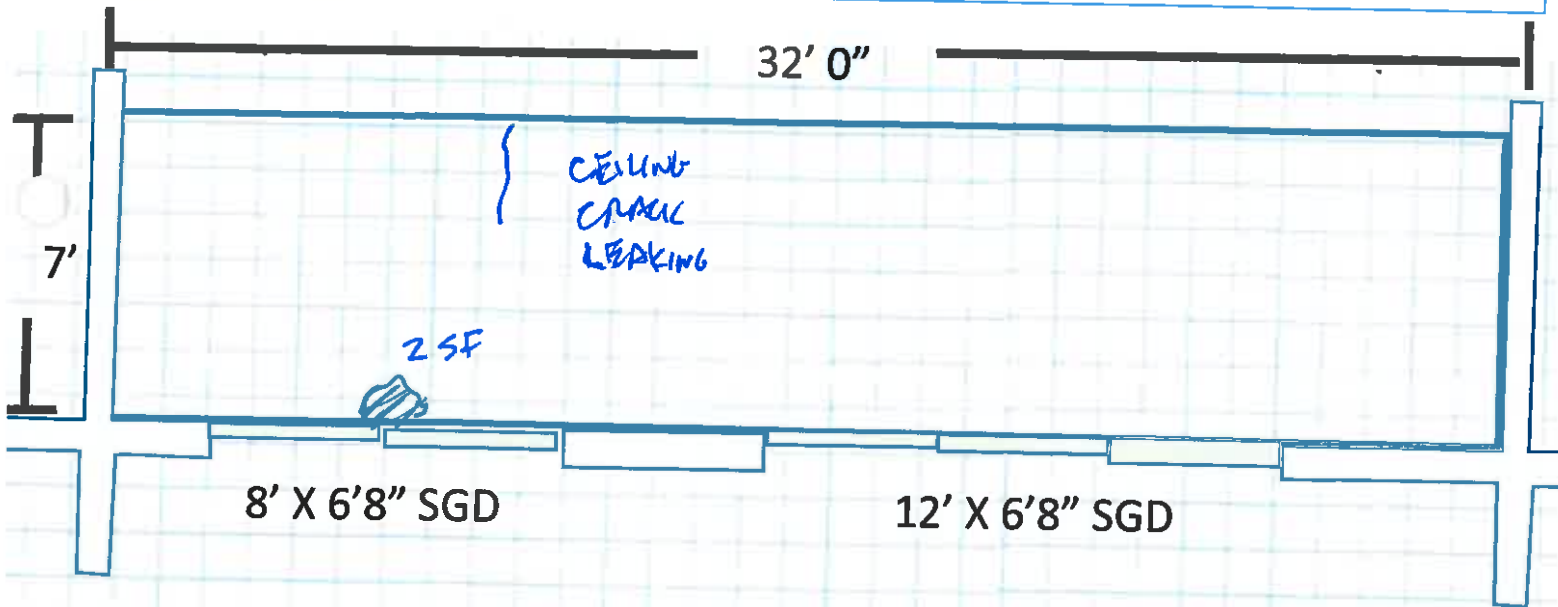
Railing Length = 32 Linear Feet
Balcony Area = 224 Square Feet

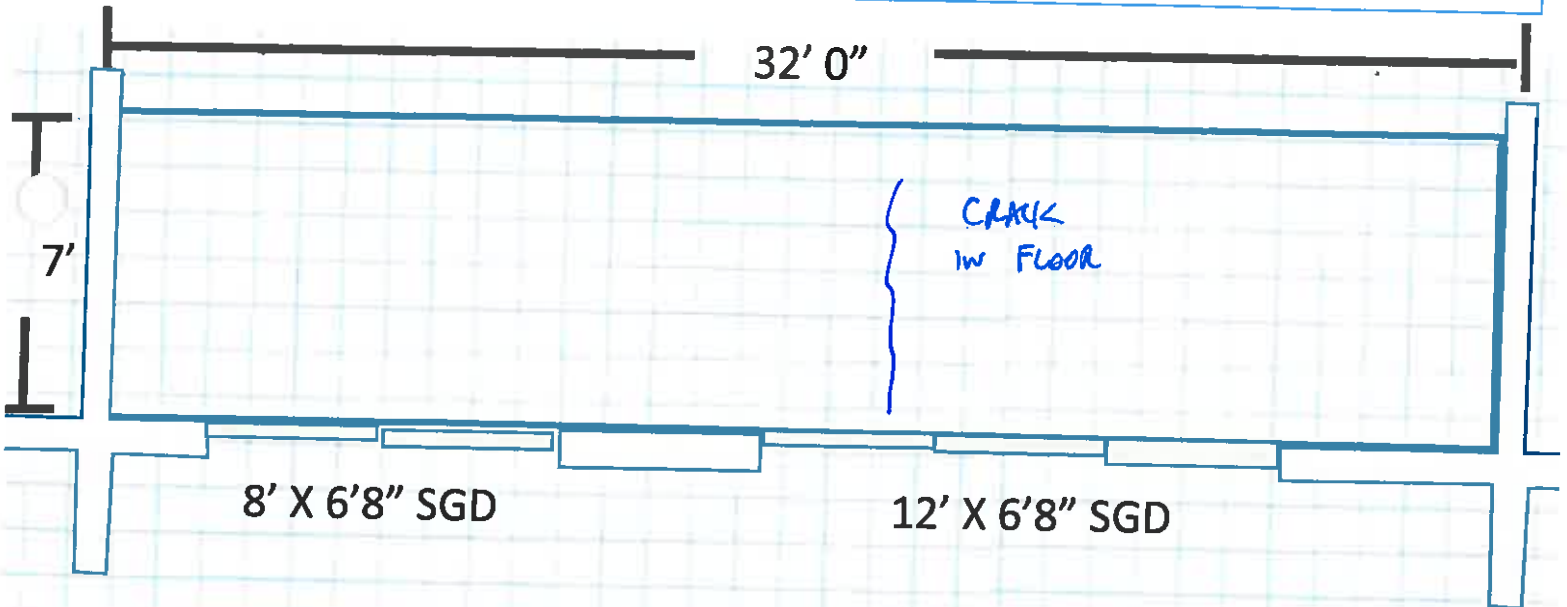
Railing Length = 32 ~~25~~ Linear Feet
Balcony Area = 224 ~~207~~ Square Feet

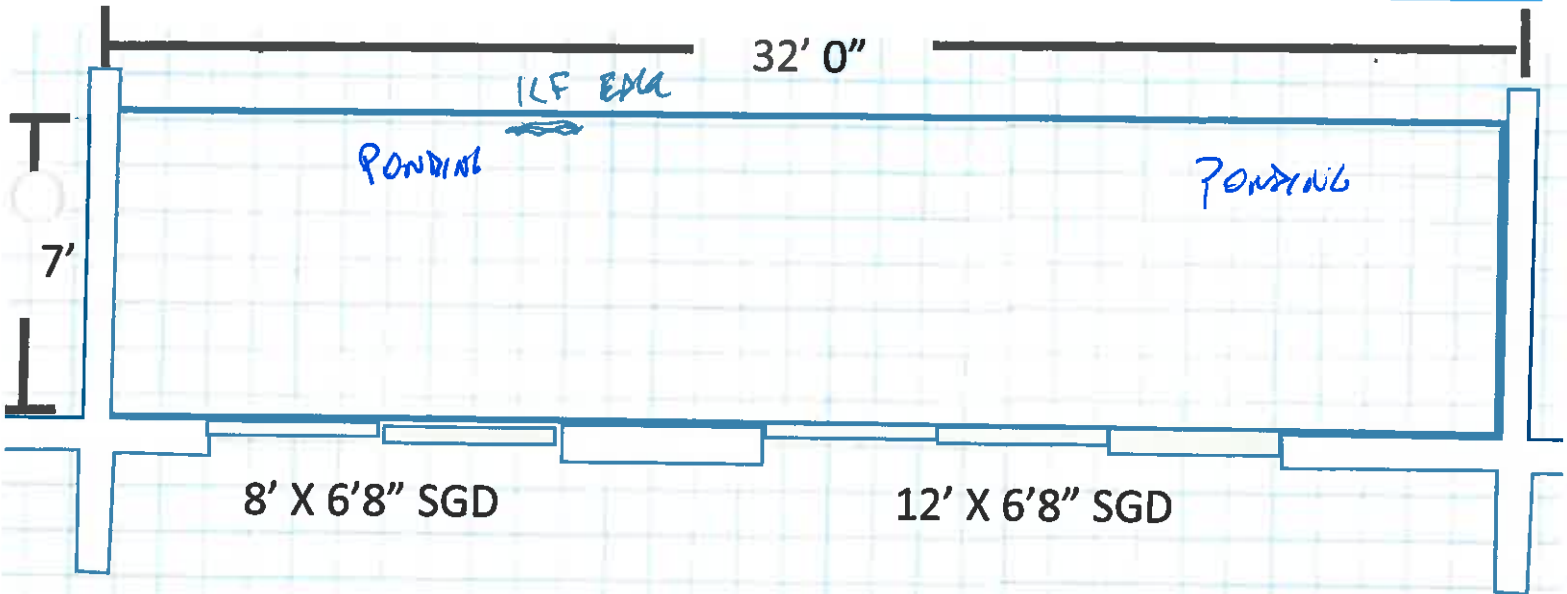
Railing Length = 32 ~~48~~ Linear Feet
Balcony Area = 224 ~~336~~ Square Feet

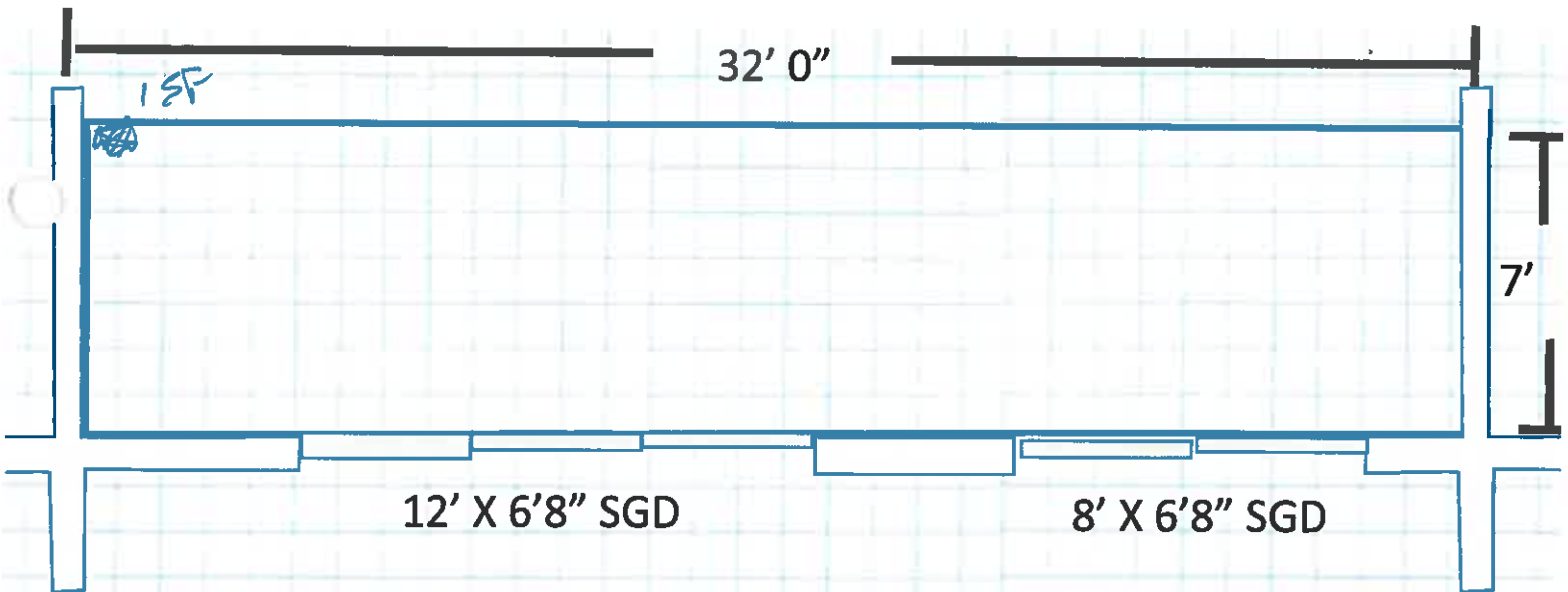
Railing Length = 32 ~~46~~ Linear Feet
Balcony Area = 224 ~~257~~ Square Feet

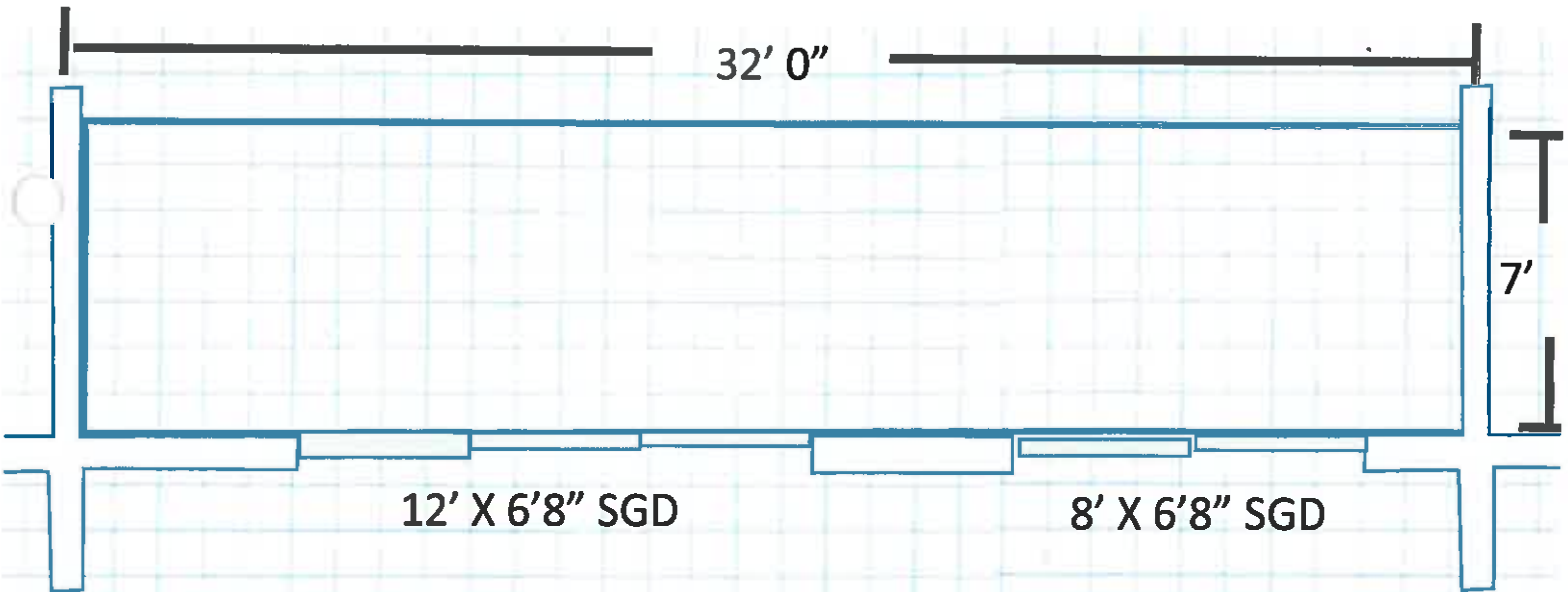
Railing Length = 32 Linear Feet
 Balcony Area = 224 Square Feet

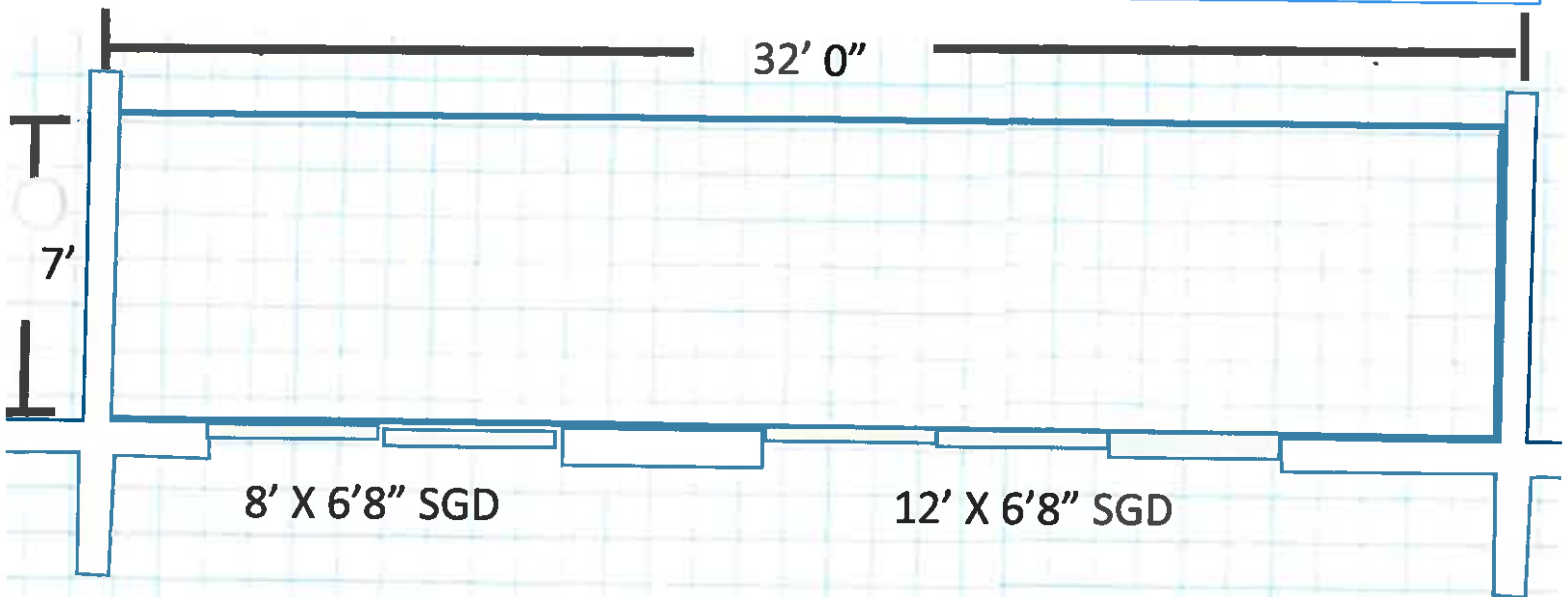
Railing Length = 32 Linear Feet
 Balcony Area = 224 Square Feet

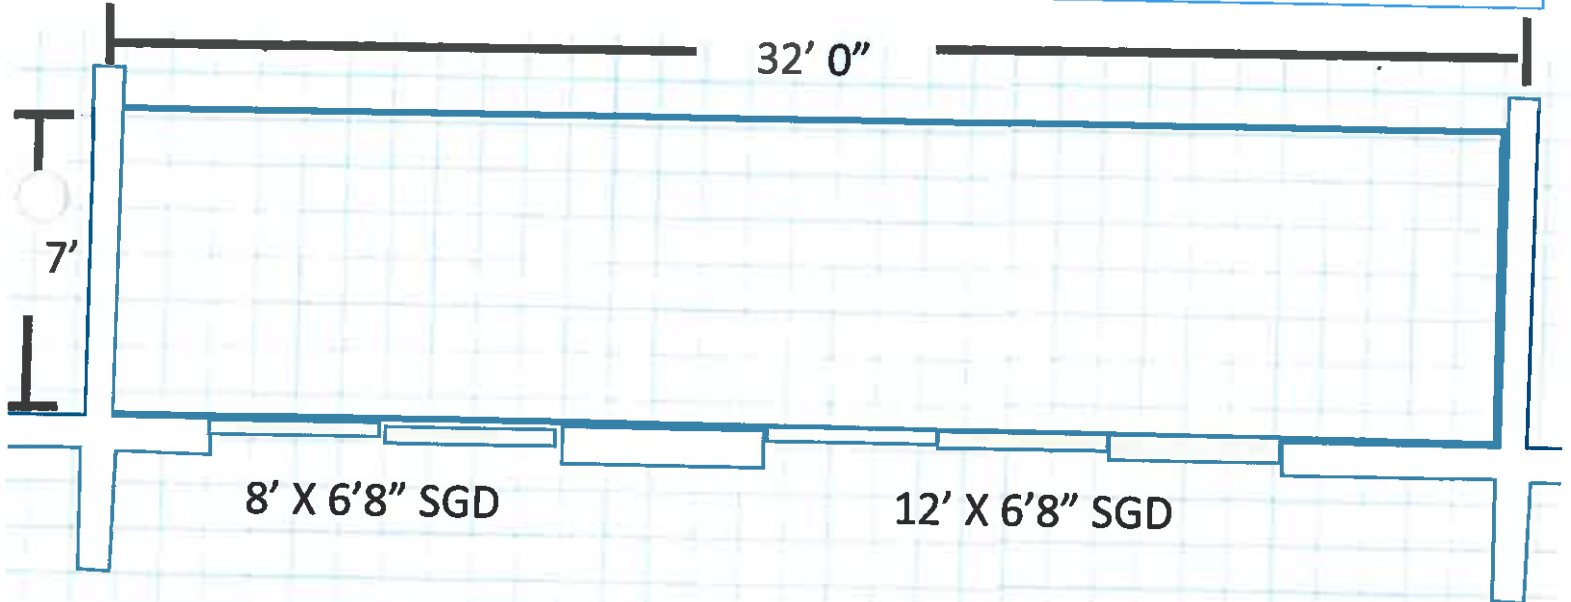
Railing Length = 32 Linear Feet
Balcony Area = 224 Square Feet

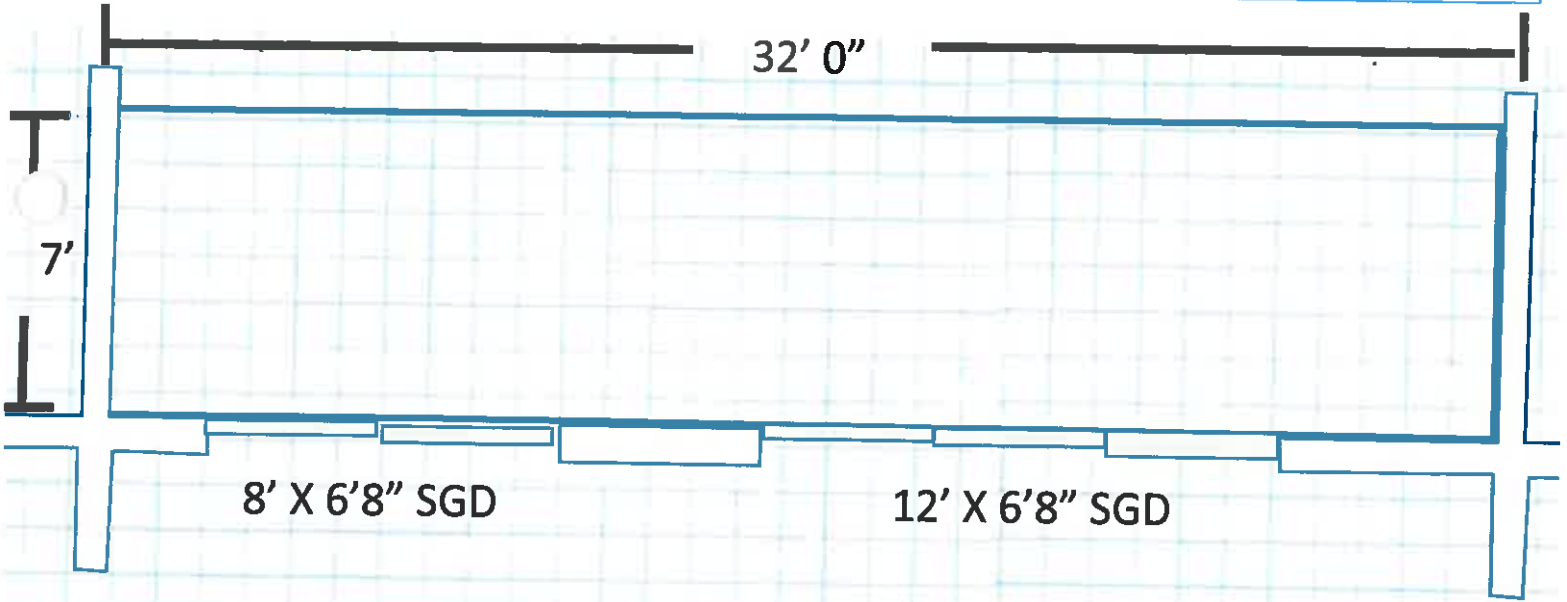
Railing Length = 32 Linear Feet
 Balcony Area = 224 Square Feet

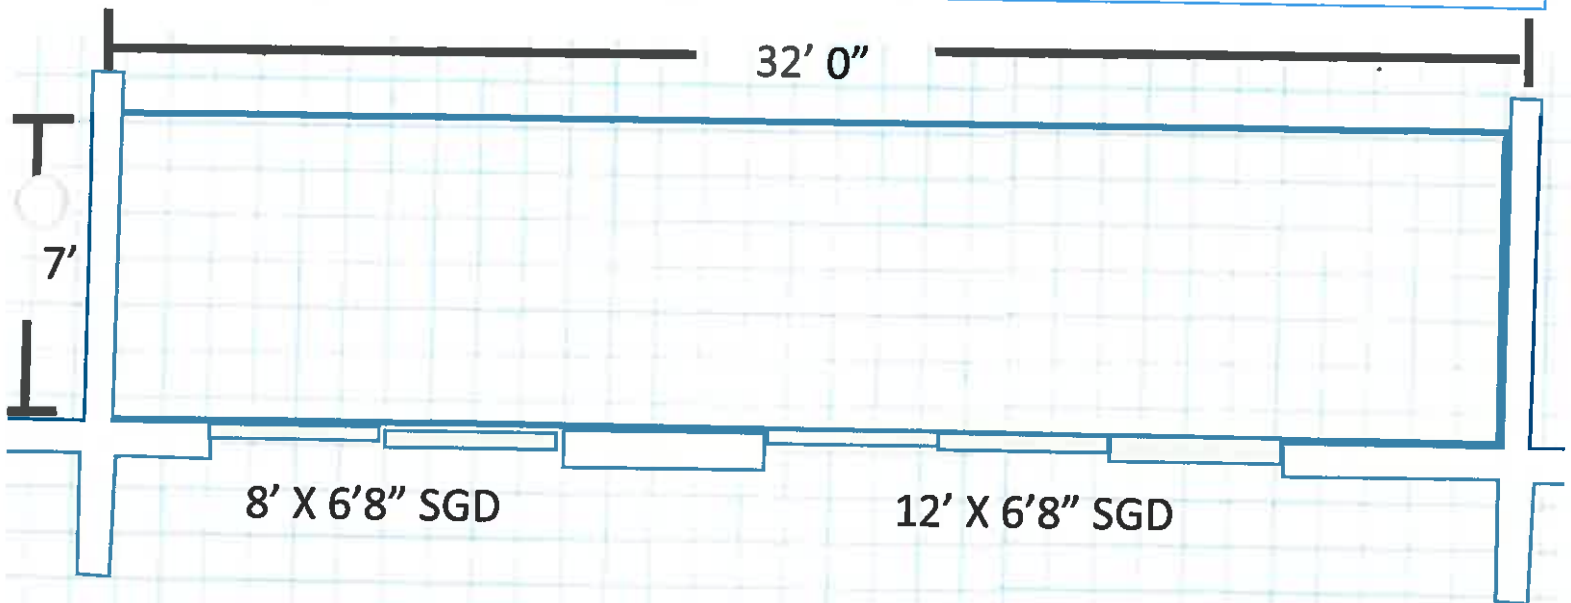
Railing Length = ~~32~~ 32 Linear Feet
Balcony Area = ~~224~~ 224 Square Feet

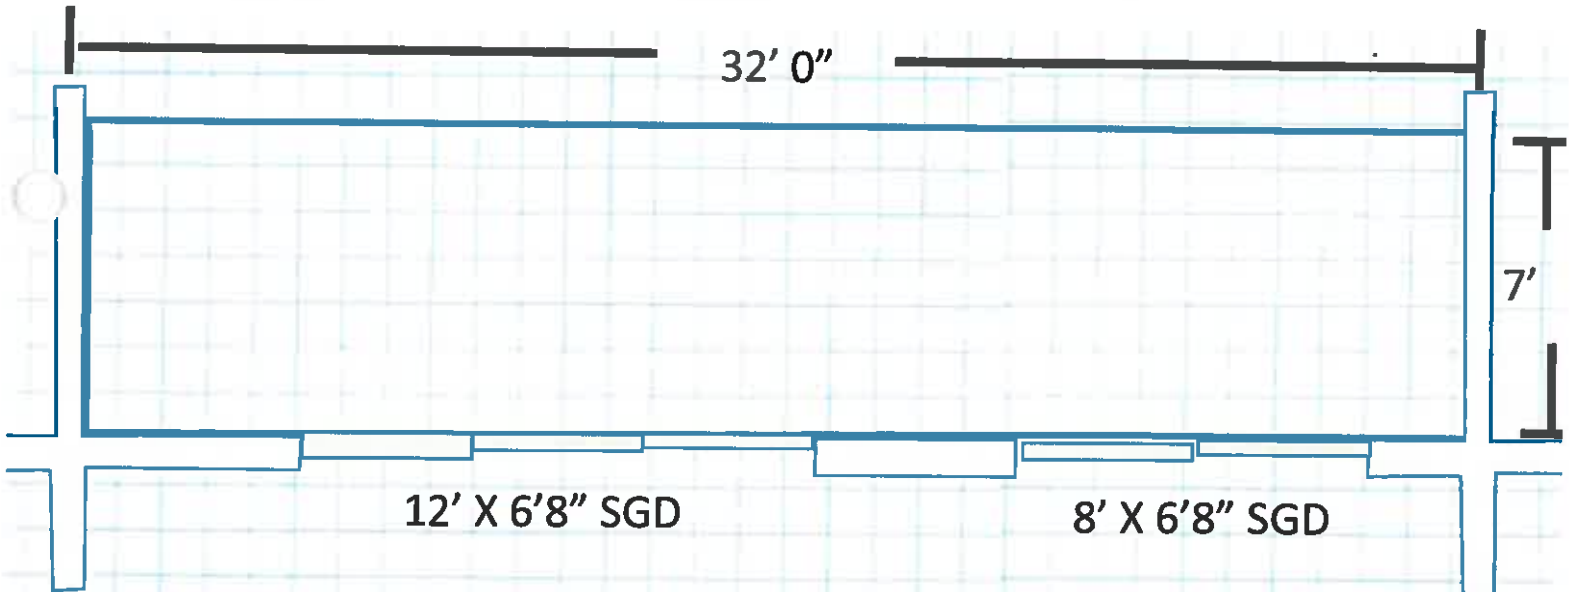
Railing Length = 32 Linear Feet
 Balcony Area = 224 Square Feet

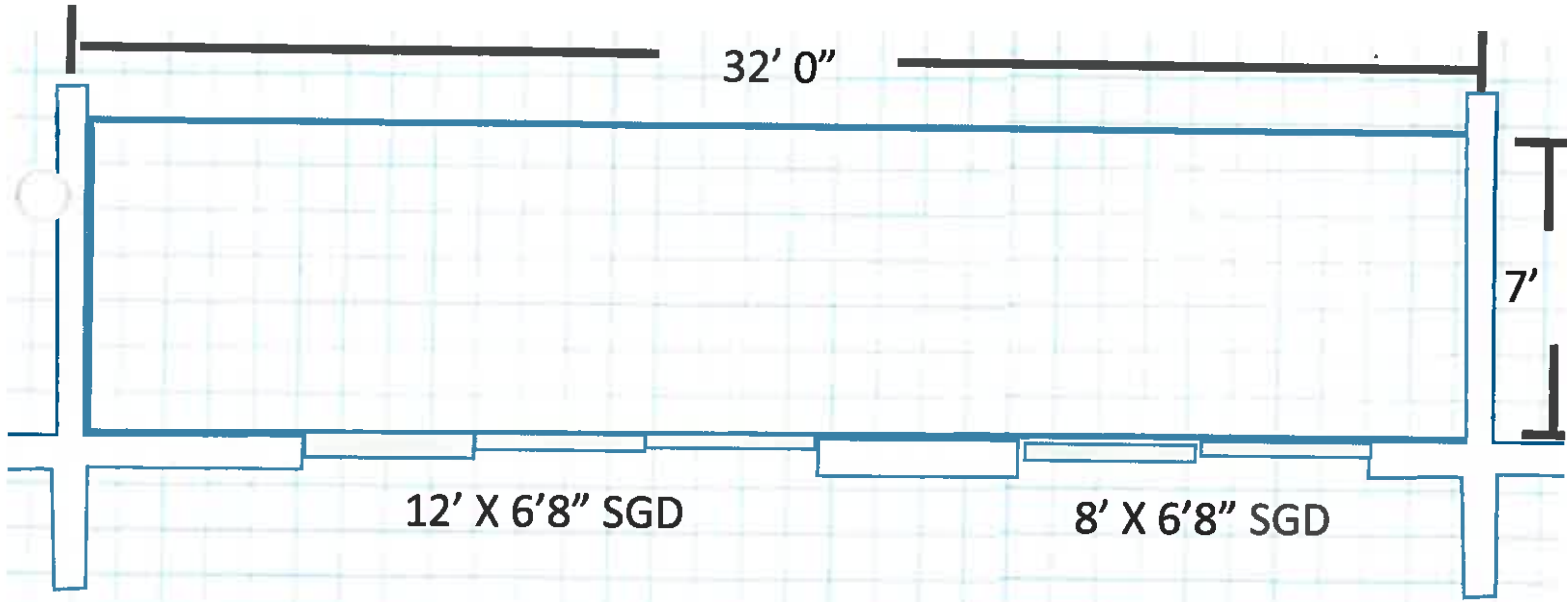
Railing Length = 32 Linear Feet
Balcony Area = 224 Square Feet
