Sunset Harbor Condominium

3873 South Banana River Boulevard
Cocoa Beach, Florida 32931

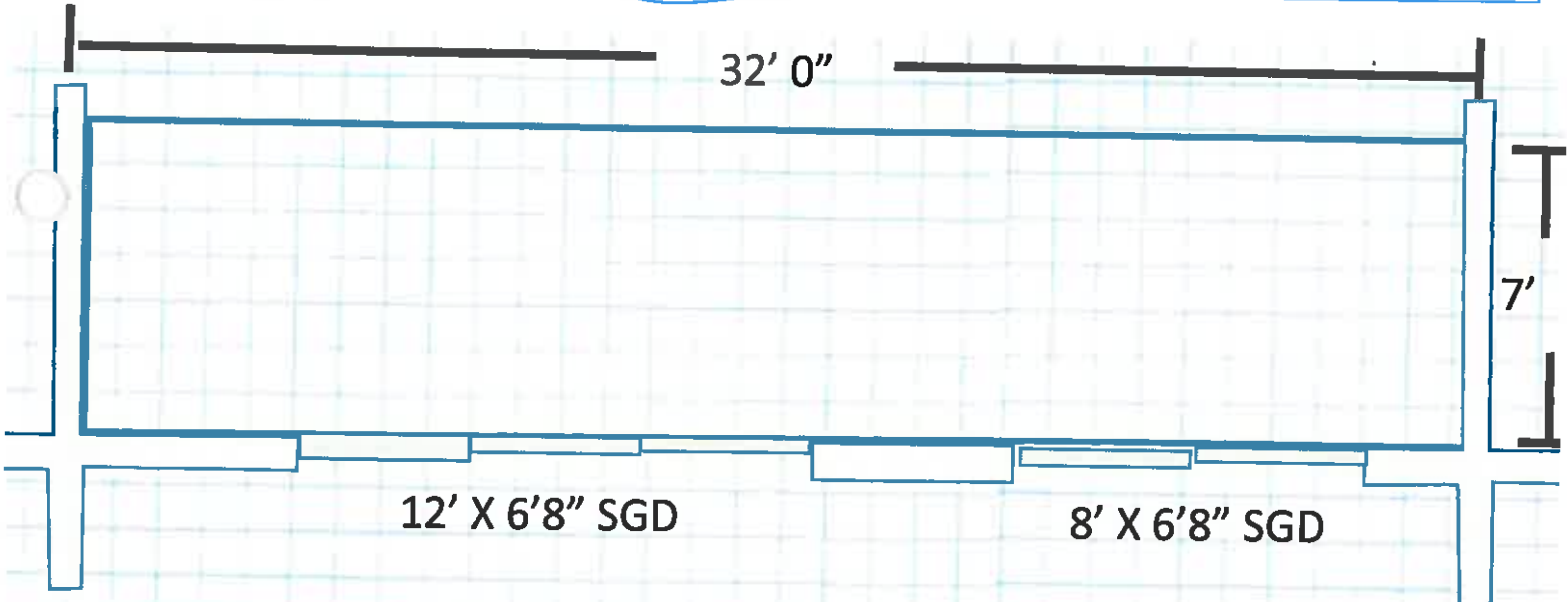
Railing Length = 32 Linear Feet
Balcony Area = 224 Square Feet

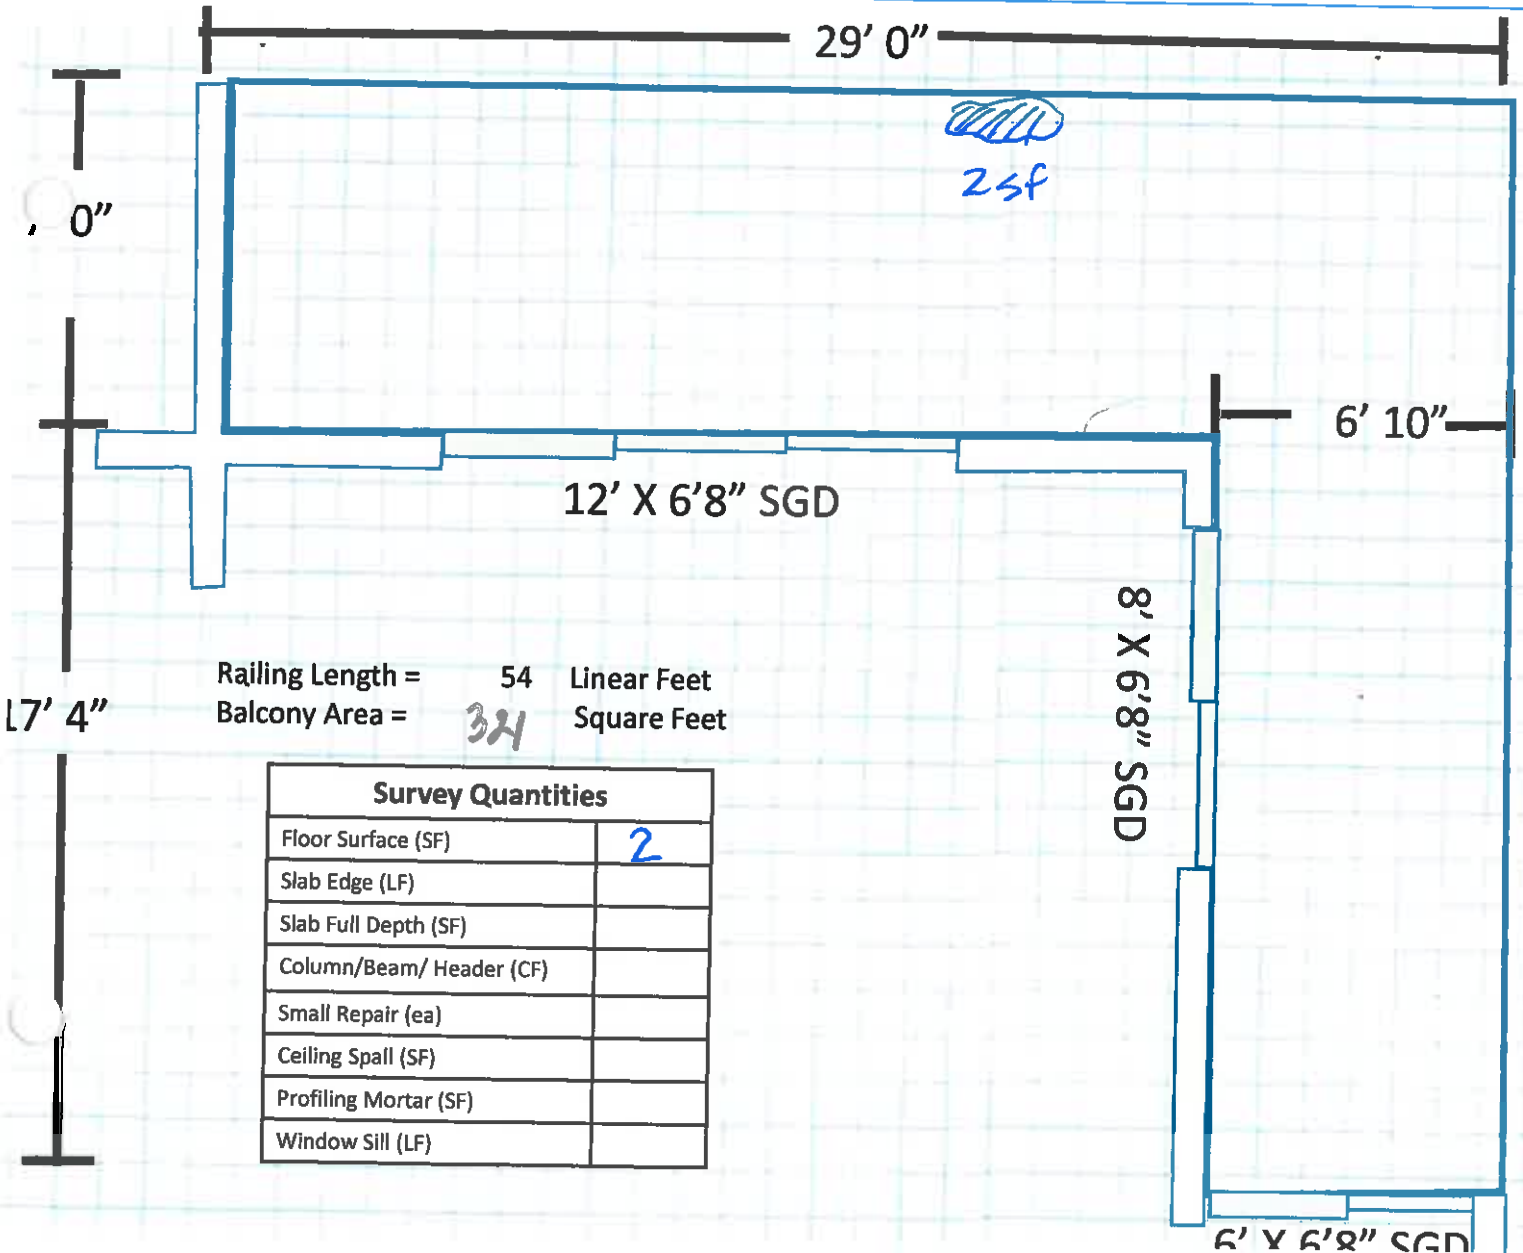
Railing Length = 54 Linear Feet
Balcony Area = 321 Square Feet

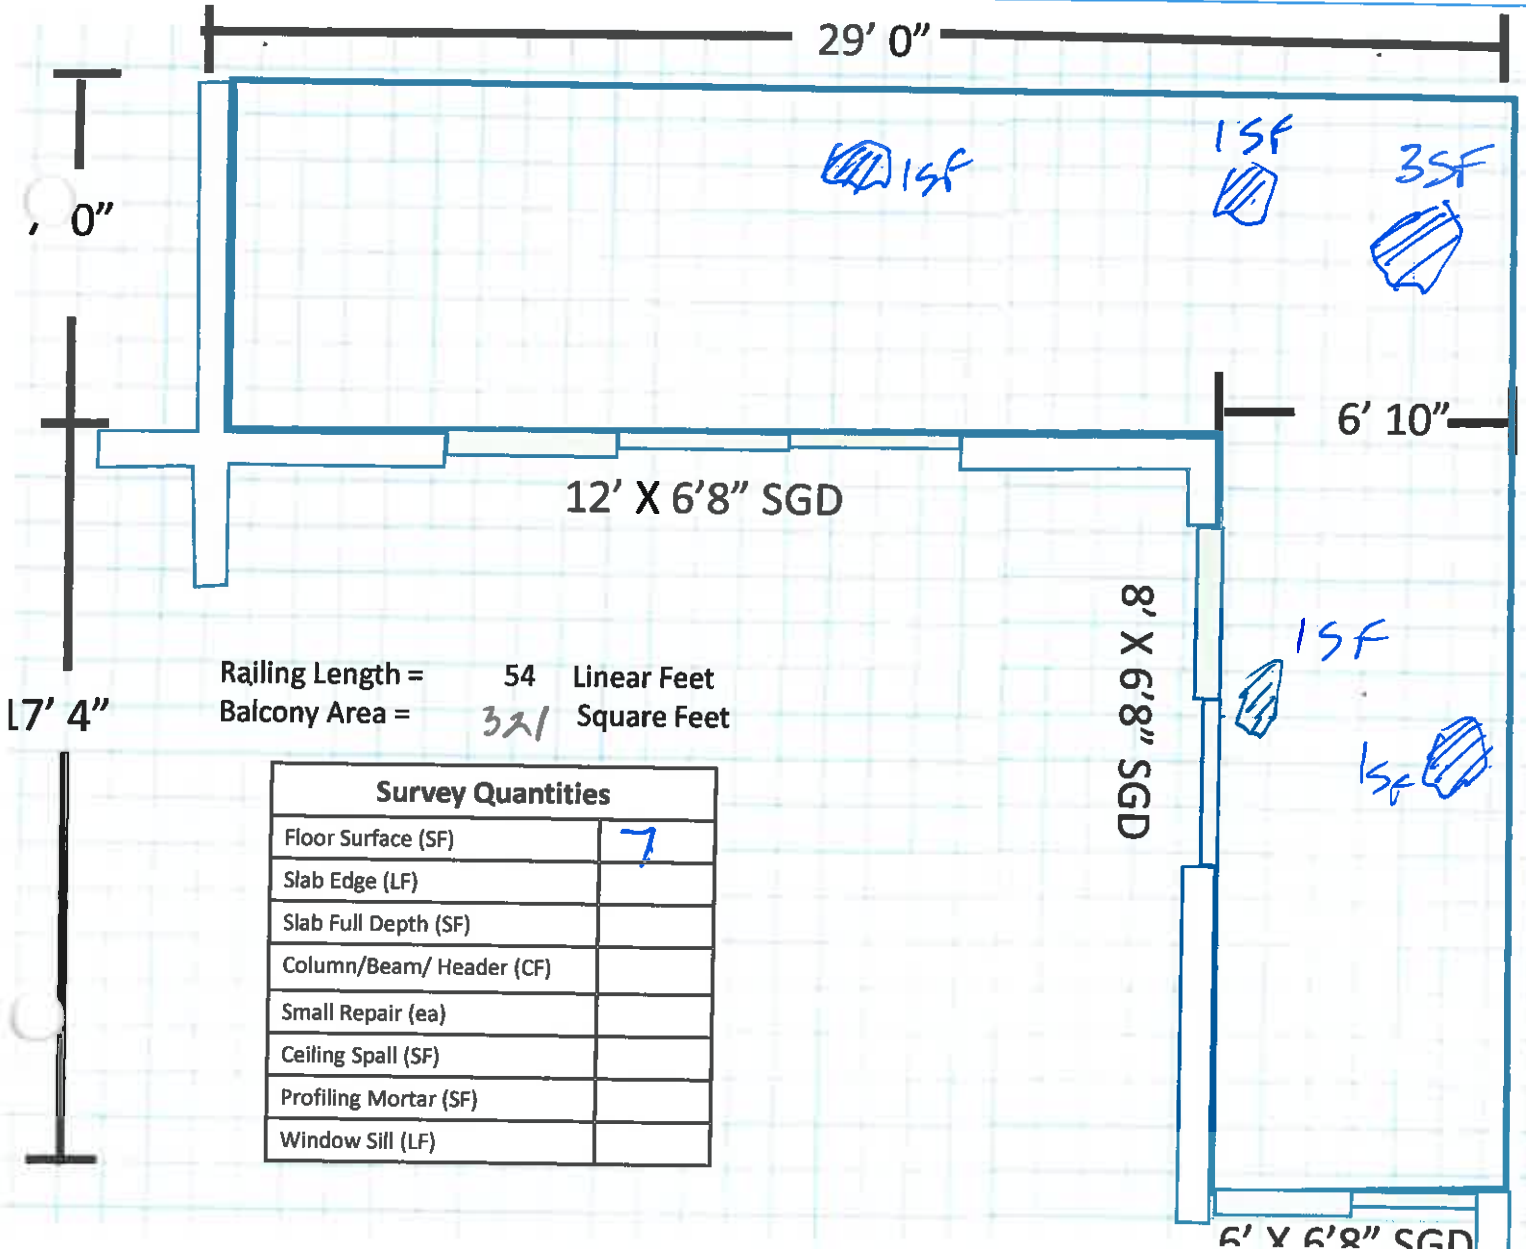
Survey Quantities	
Floor Surface (SF)	7
Slab Edge (LF)	
Slab Full Depth (SF)	
Column/Beam/ Header (CF)	
Small Repair (ea)	
Ceiling Spall (SF)	
Profiling Mortar (SF)	
Window Sill (LF)

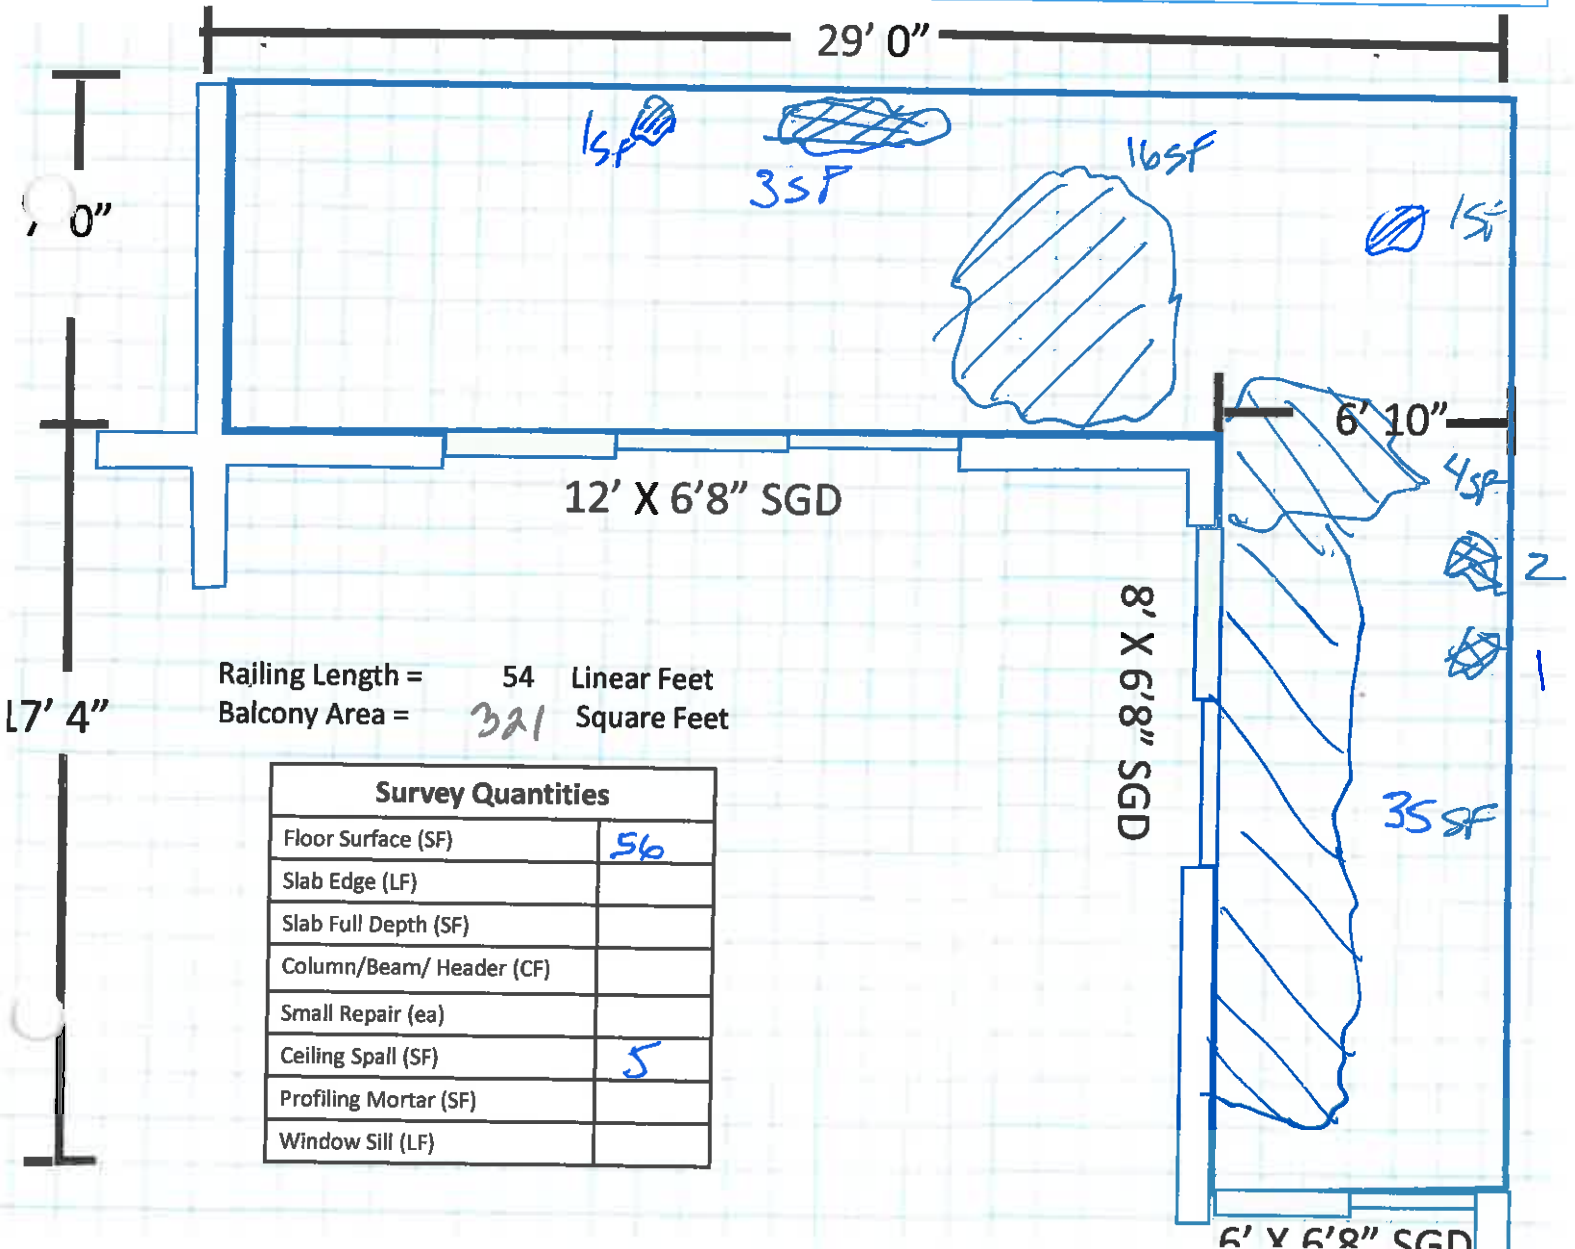
LEGEND		Railings			Sliding Doors		Flooring	
	Spall Above	Code Compliant: <u>Yes</u> No			Vinyl Aluminum			
	Spall Below	Condition: Good <u>Fair</u> Poor			Code Compliant: <u>Yes</u> No			
	Crack	Type: Cored <u>Surface Mount</u> Screen			Condition: <u>Good</u> Fair Poor			
	Rust Spot	Screen Shimmed: Yes No			Age: <u>Older</u> Newer			
		<u>Shutters</u>	<u>Yes</u> No			Corroded Fasteners: Yes No		
		Shimmed	Yes No			Holes In Threshold: Yes No		
		<u>Edge</u> Door						
		Accordion <u>Roll Down</u>						
					Type: Tile <u>Coating</u> Pattern

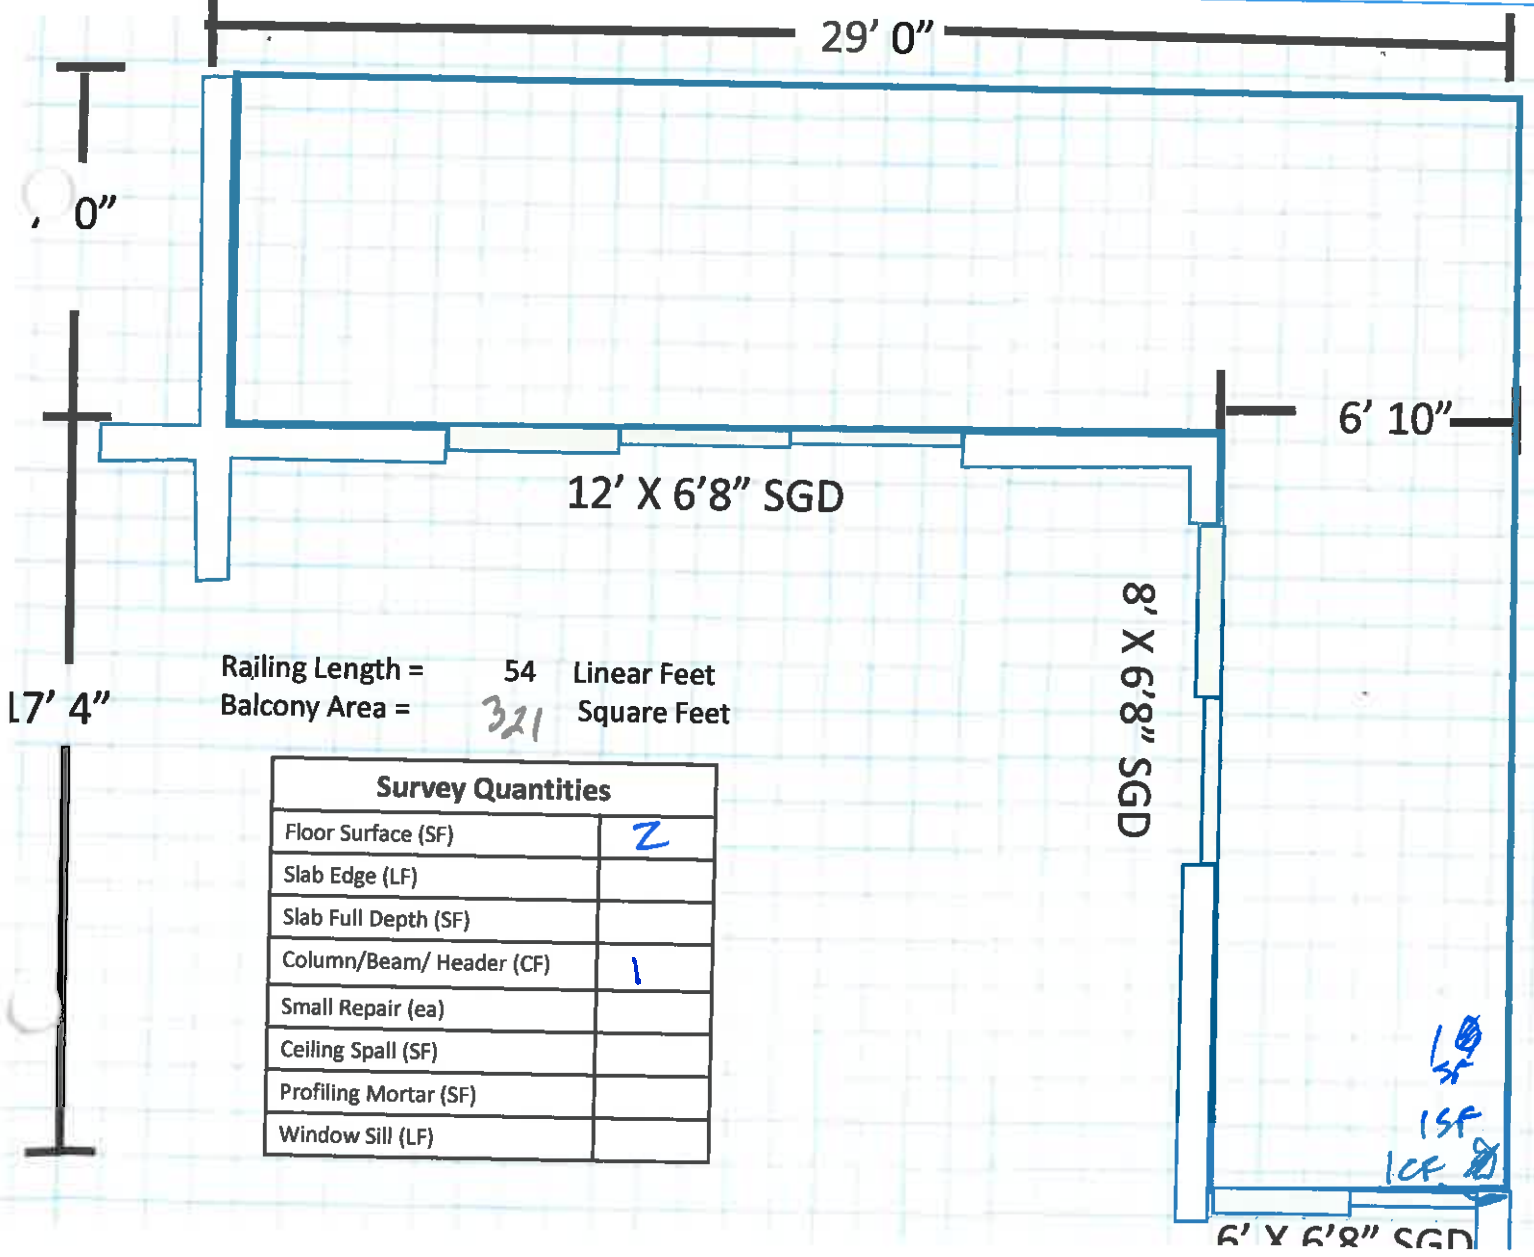
LEGEND		Railings		Sliding Doors	
	Spall Above	Code Compliant: <u>Yes</u> No		Vinyl Aluminum	
	Spall Below	Condition: <u>Good</u> <u>Fair</u> Poor		Code Compliant: <u>Yes</u> No	
	Crack	Type: Cored <u>Surface Mount</u> Screen		Condition: <u>Good</u> Fair Poor	
	Rust Spot	Screen Shimmed: Yes No		Age: <u>Older</u> Newer	
		<u>Shutters</u>	<u>Yes</u> No	Corroded Fasteners: Yes <u>No</u>	
		Shimmed	Yes No	Holes In Threshold: Yes <u>No</u>	
		<u>Edge</u>	<u>Door</u>		
		Accordion	<u>Roll Down</u>		
				Flooring	
				Type: Tile <u>Coating</u> Pattern

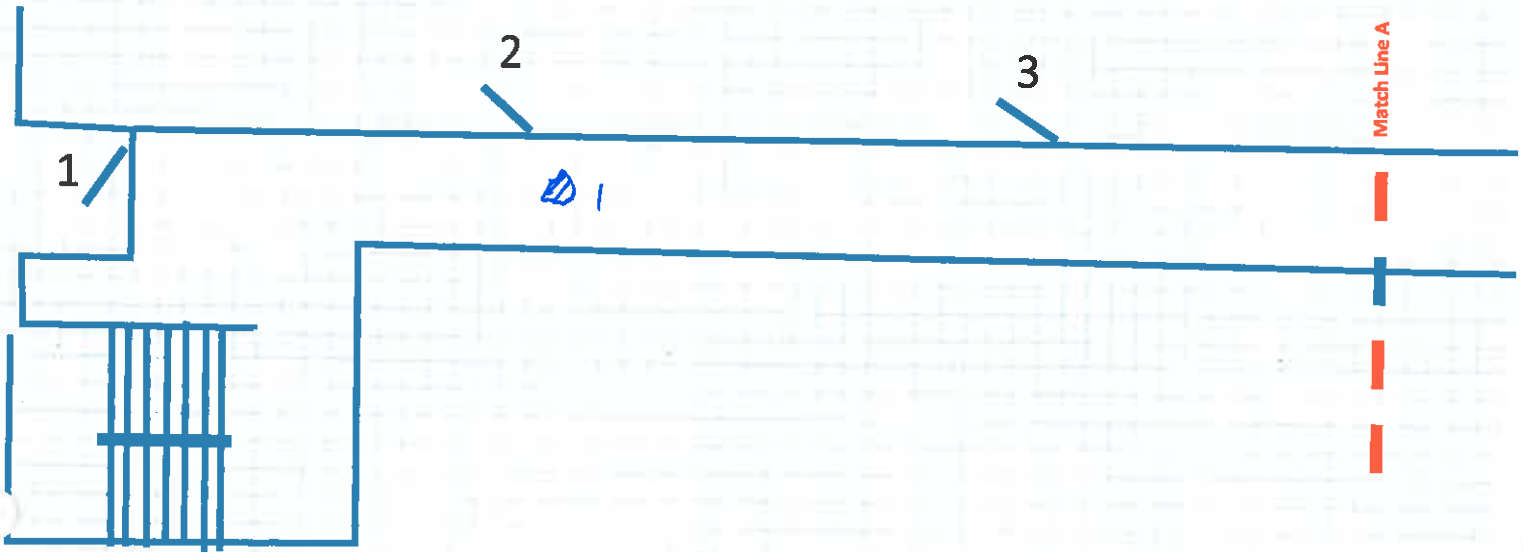
Survey Quantities	
Floor Surface (SF)	1
Slab Edge (LF)	
Slab Full Depth (SF)	
Column/Beam/ Header (CF)	
Small Repair (ea)	
Ceiling Spall (SF)	
Profiling Mortar (SF)	
Window Sill (LF)

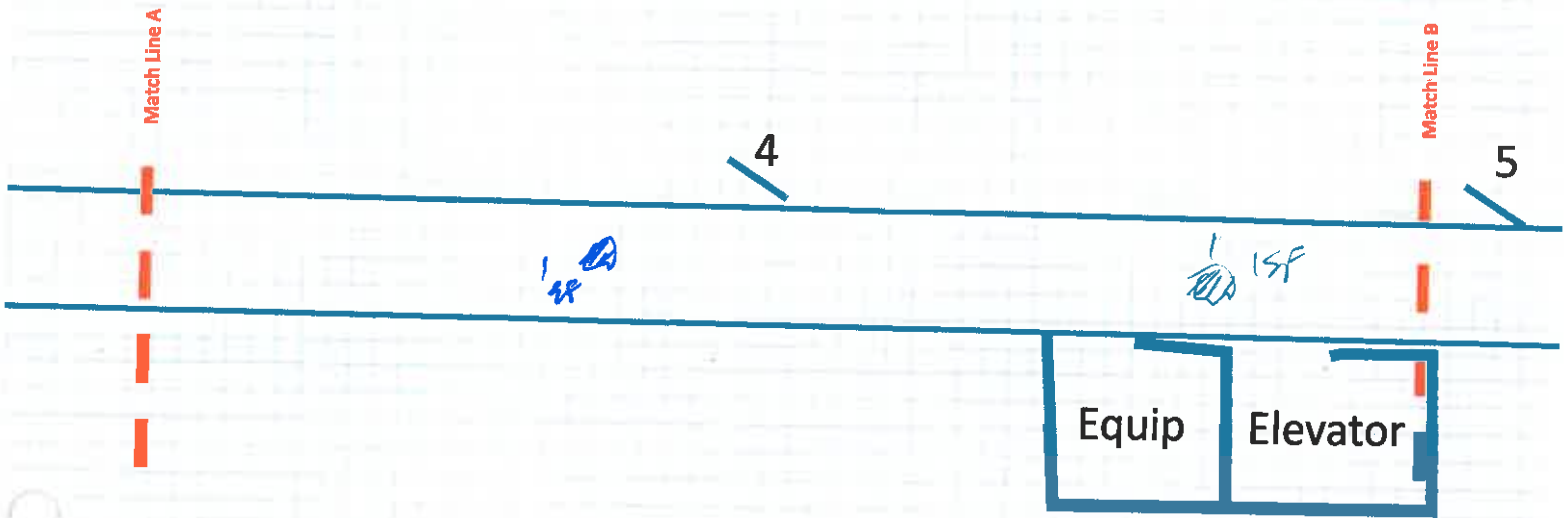
Survey Quantities	
Floor Surface (SF)	2
Slab Edge (LF)	
Slab Full Depth (SF)	
Column/Beam/ Header (CF)	
Small Repair (ea)	
Ceiling Spall (SF)	
Profiling Mortar (SF)	
Window Sill (LF)

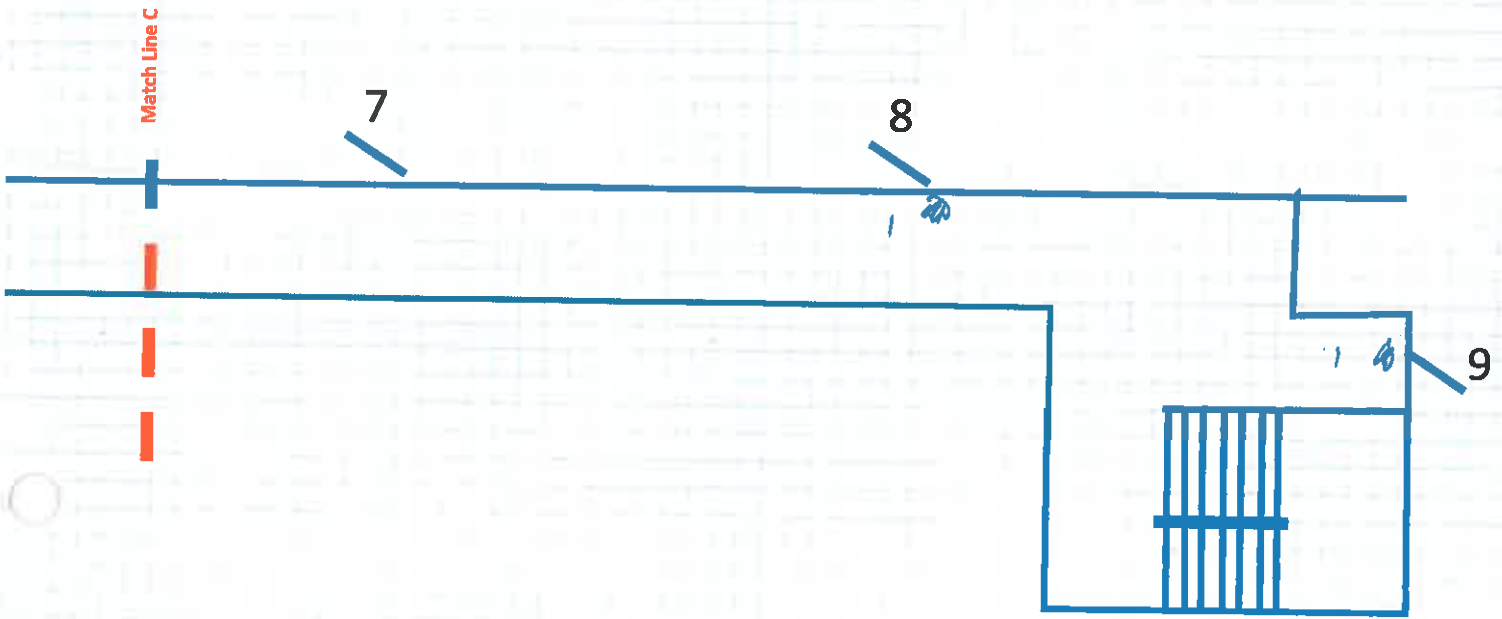
Survey Quantities	
Floor Surface (SF)	2
Slab Edge (LF)	
Slab Full Depth (SF)	
Column/Beam/ Header (CF)	
Small Repair (ea)	
Ceiling Spall (SF)	
Profiling Mortar (SF)	
Window Sill (LF)

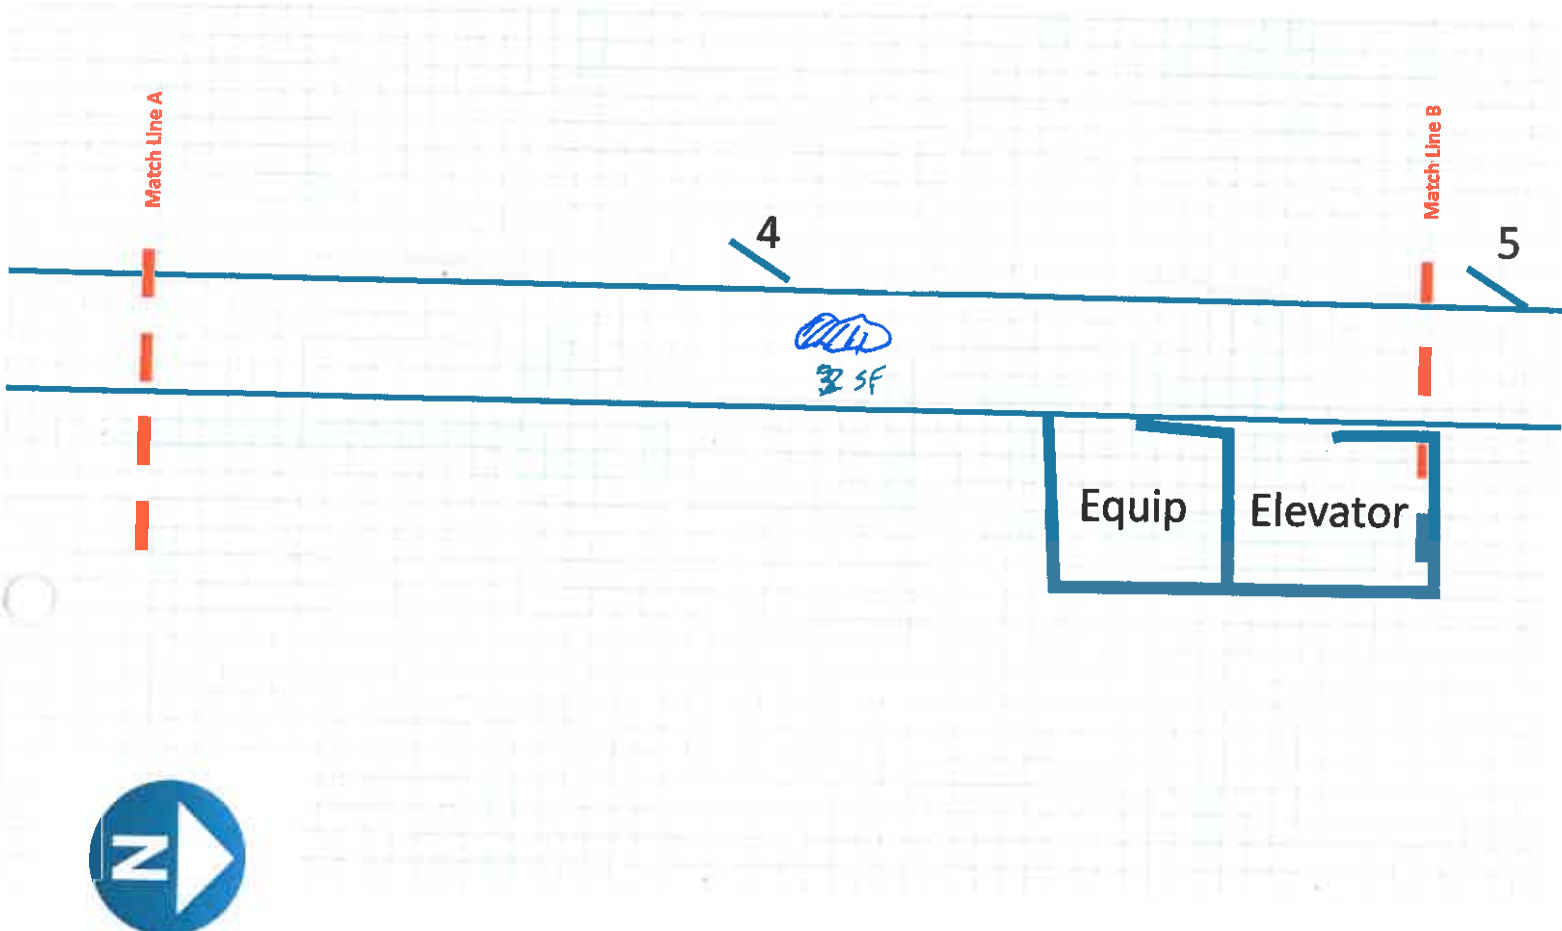
Survey Quantities	
Floor Surface (SF)	3
Slab Edge (LF)	
Slab Full Depth (SF)	
Column/Beam/ Header (CF)	
Small Repair (ea)	
Ceiling Spall (SF)	
Profiling Mortar (SF)	
Window Sill (LF)

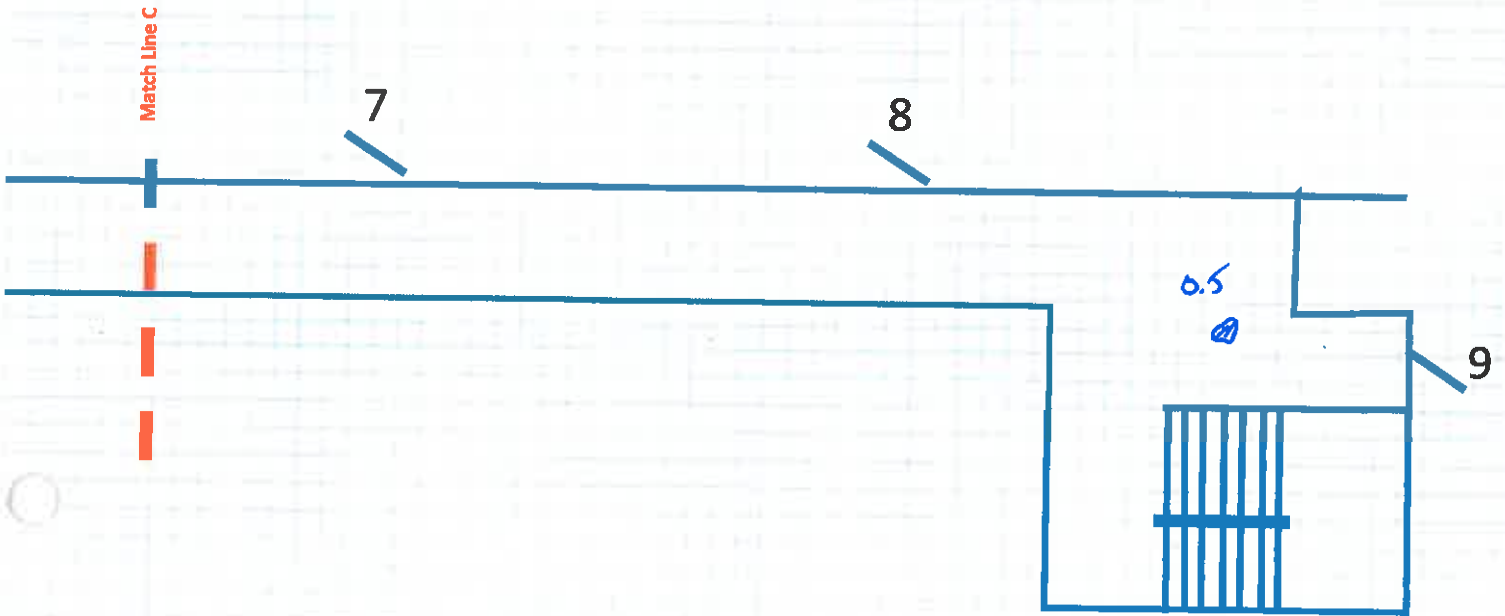
Survey Quantities	
Floor Surface (SF)	0.5
Slab Edge (LF)	
Slab Full Depth (SF)	
Column/Beam/ Header (CF)	
Small Repair (ea)	
Ceiling Spall (SF)	
Profiling Mortar (SF)	
Window Sill (LF)

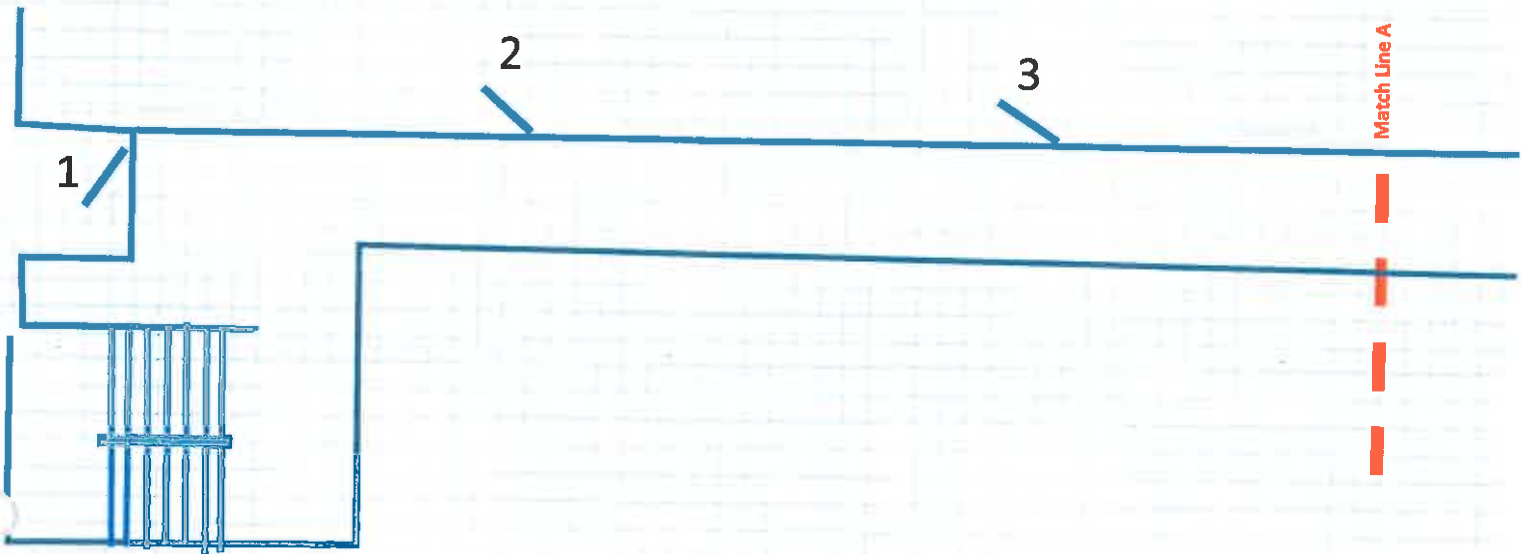
Survey Quantities	
Floor Surface (SF)	
Slab Edge (LF)	
Slab Full Depth (SF)	
Column/Beam/ Header (CF)	
Small Repair (ea)	
Ceiling Spall (SF)	
Profiling Mortar (SF)	
Window Sill (LF)

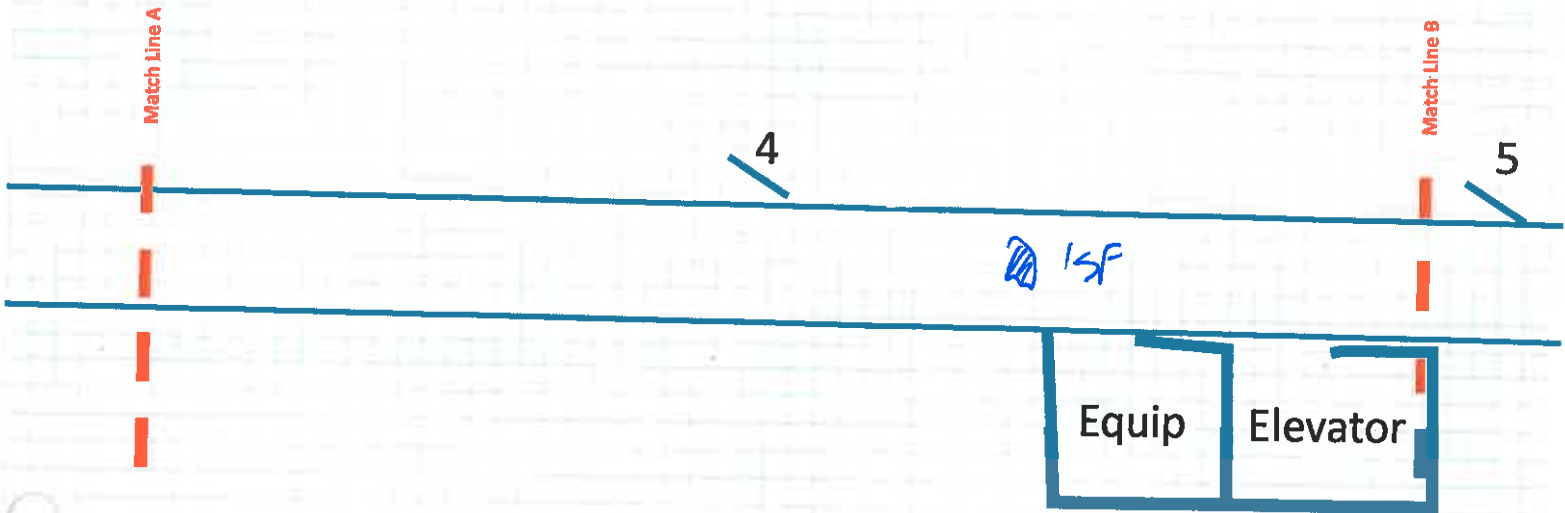
Survey Quantities	
Floor Surface (SF)	1
Slab Edge (LF)	
Slab Full Depth (SF)	
Column/Beam/ Header (CF)	
Small Repair (ea)	
Ceiling Spall (SF)	
Profiling Mortar (SF)	
Window Sill (LF)

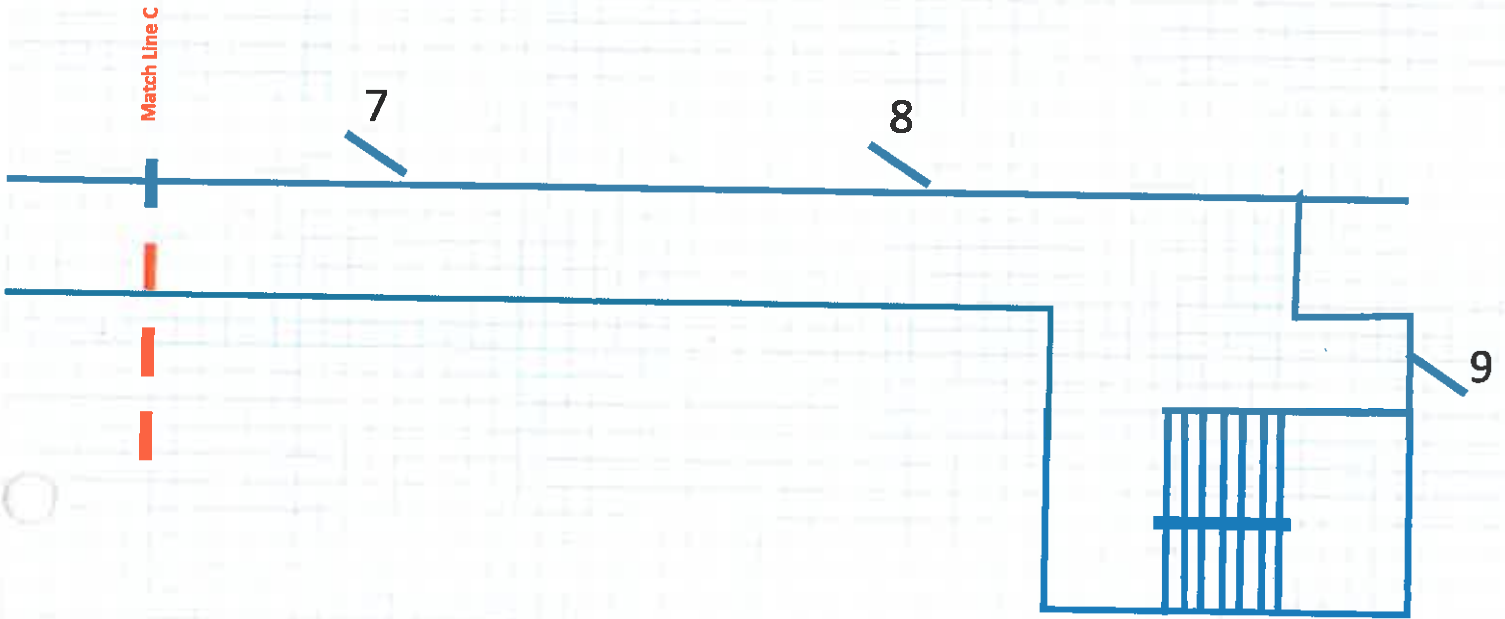
Survey Quantities	
Floor Surface (SF)	
Slab Edge (LF)	
Slab Full Depth (SF)	
Column/Beam/ Header (CF)	
Small Repair (ea)	
Ceiling Spall (SF)	
Profiling Mortar (SF)	
Window Sill (LF)

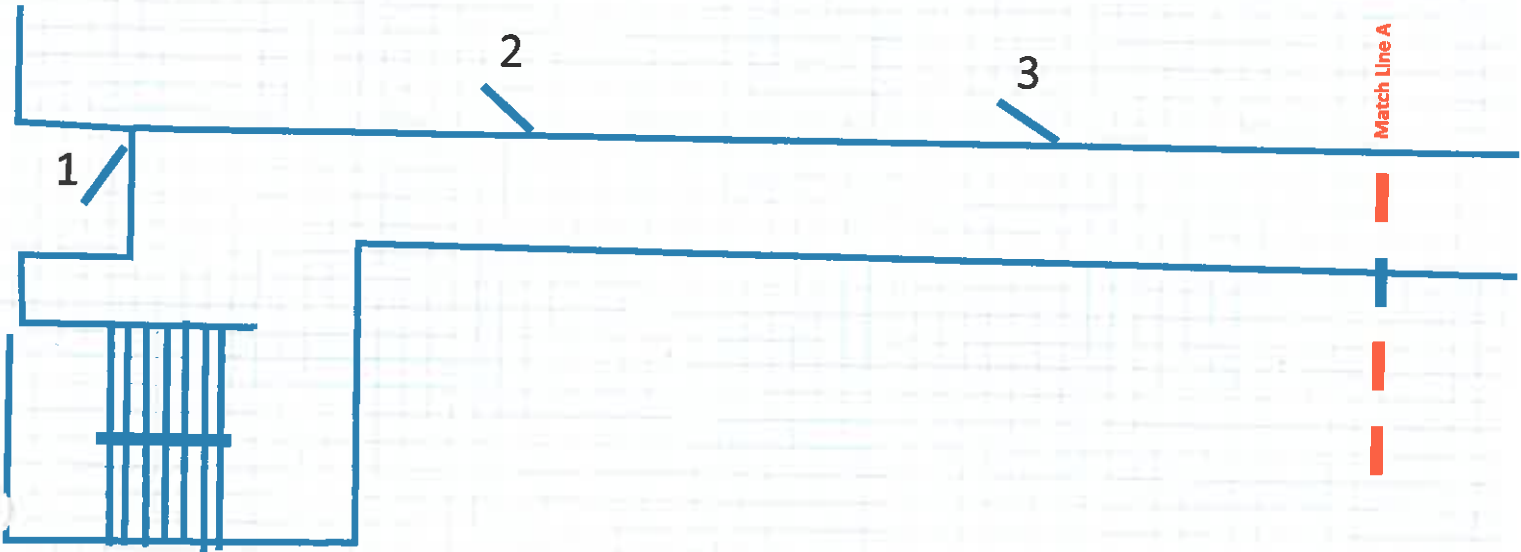
Survey Quantities	
Floor Surface (SF)	
Slab Edge (LF)	
Slab Full Depth (SF)	
Column/Beam/ Header (CF)	
Small Repair (ea)	
Ceiling Spall (SF)	
Profiling Mortar (SF)	
Window Sill (LF)

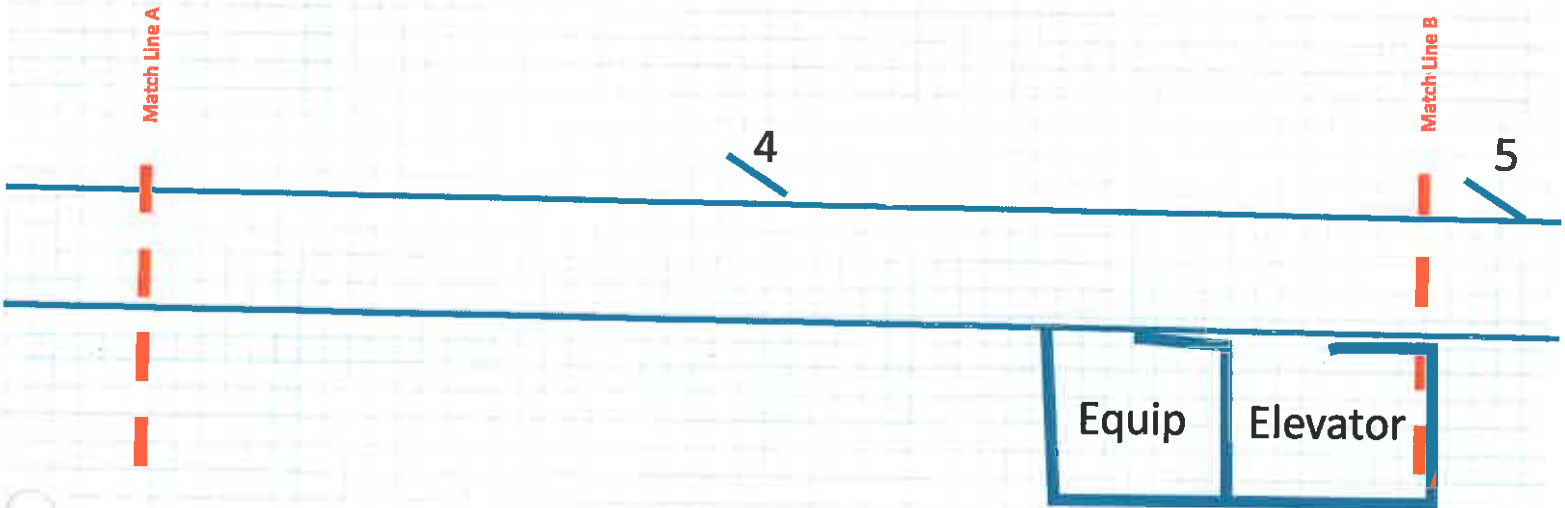
Survey Quantities	
Floor Surface (SF)	
Slab Edge (LF)	
Slab Full Depth (SF)	
Column/Beam/ Header (CF)	
Small Repair (ea)	
Ceiling Spall (SF)	
Profiling Mortar (SF)	
Window Sill (LF)

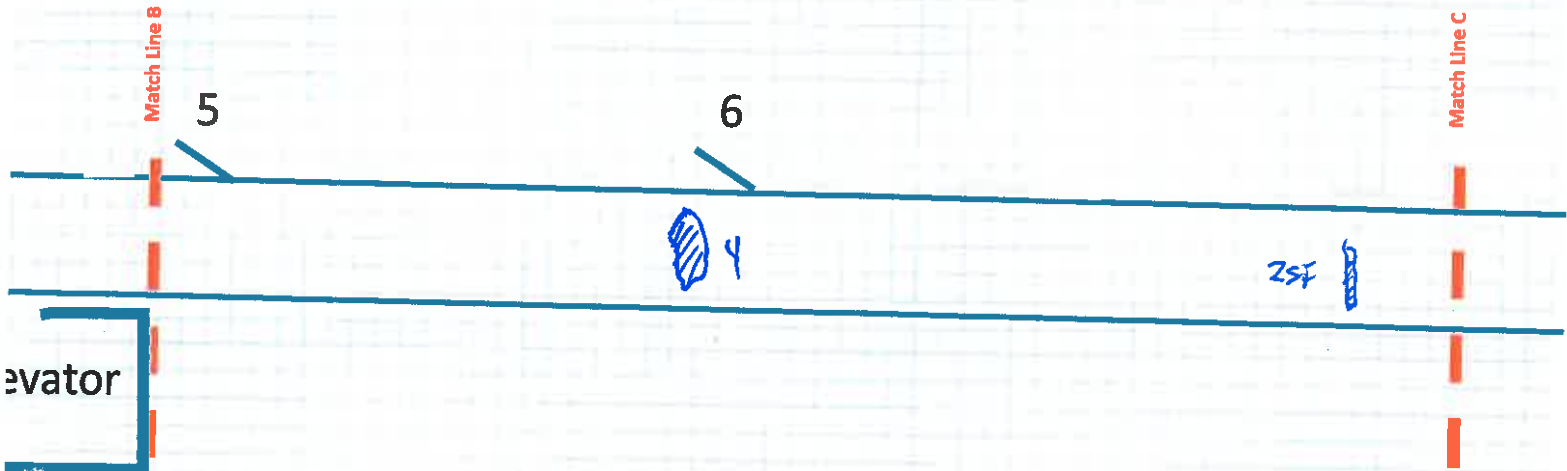
Survey Quantities	
Floor Surface (SF)	<u>6</u>
Slab Edge (LF)	
Slab Full Depth (SF)	
Column/Beam/ Header (CF)	
Small Repair (ea)	
Ceiling Spall (SF)	
Profiling Mortar (SF)	
Window Sill (LF)

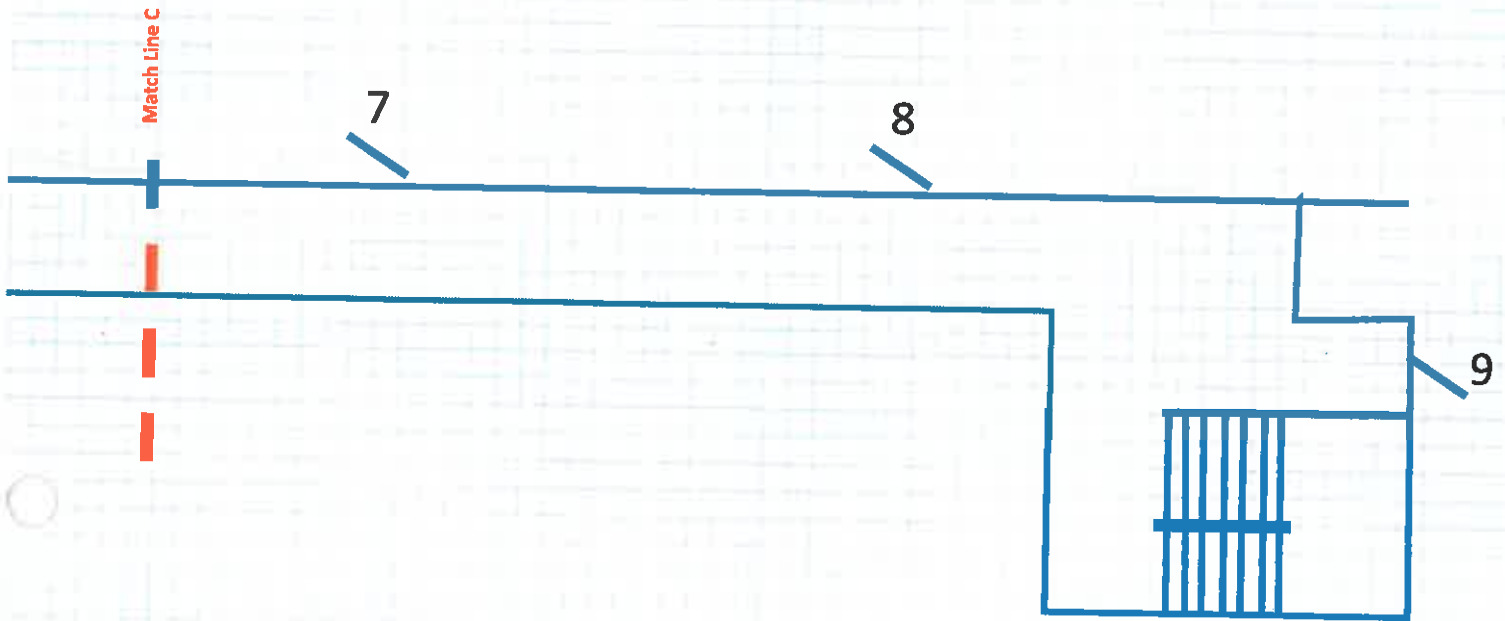
Survey Quantities	
Floor Surface (SF)	
Slab Edge (LF)	
Slab Full Depth (SF)	
Column/Beam/ Header (CF)	
Small Repair (ea)	
Ceiling Spall (SF)	
Profiling Mortar (SF)	
Window Sill (LF)
