# Uniform Mitigation Verification Inspection Form

Inspection Date: 03/12/2024		
<b>Owner Information</b>		
Owner Name: Sunset Harbor Owner's Association		Contact Person:
Address: 3873 S Banana River Blvd		Home Phone:
City: Cocoa Beach	Zip: 32931	Work Phone:
County: Brevard		Cell Phone: (313) 477-5508
Insurance Company:		Policy #:
Year of Home: 1985	# of Stories: 5	Email: sunsetharbor3873@yahoo.com

Inspectors Initials BC Property Address 3873 S Banana River Blvd Cocoa Beach Fl 32931

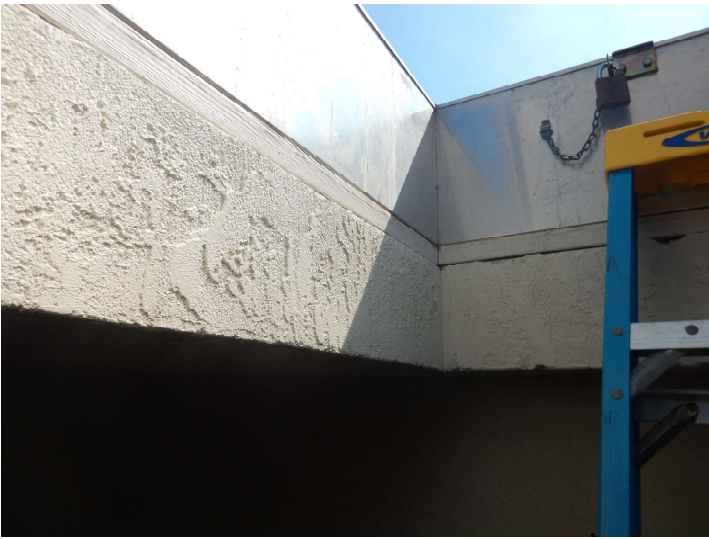
- D. Reinforced Concrete Roof Deck.
- E. Other: \_\_\_\_\_
- F. Unknown or unidentified.
- G. No attic access.

Concrete Roof Deck

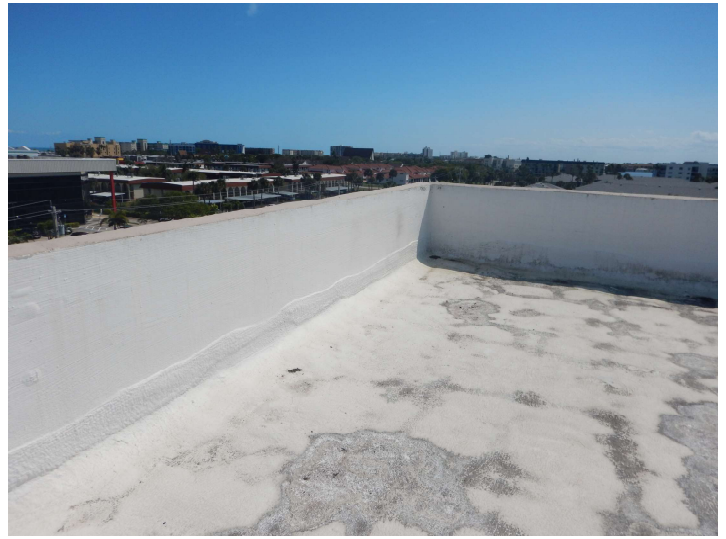
- E. Structural      Anchor bolts structurally connected or reinforced concrete roof.
- F. Other: \_\_\_\_\_
- G. Unknown or unidentified
- H. No attic access

Structurally Attached
